Failure of the Stem in Total Hip Replacement

A Study of Aetiology and Mechanism of Failure in 13 Cases

Ugo E. Pazzaglia¹, Franco Ghisellini², Daniele Barbieri¹, and Luciano Ceciliani¹

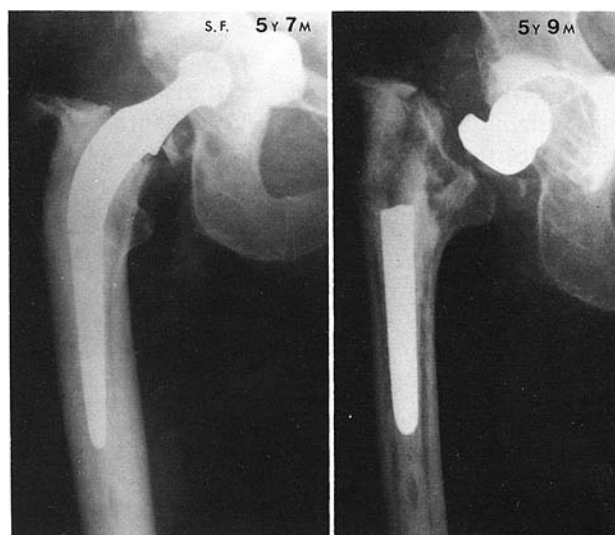
Fig. 1. Fracture of the stem 5 years and 7 months after implantation and displacement of the proximal fragment two months later after load

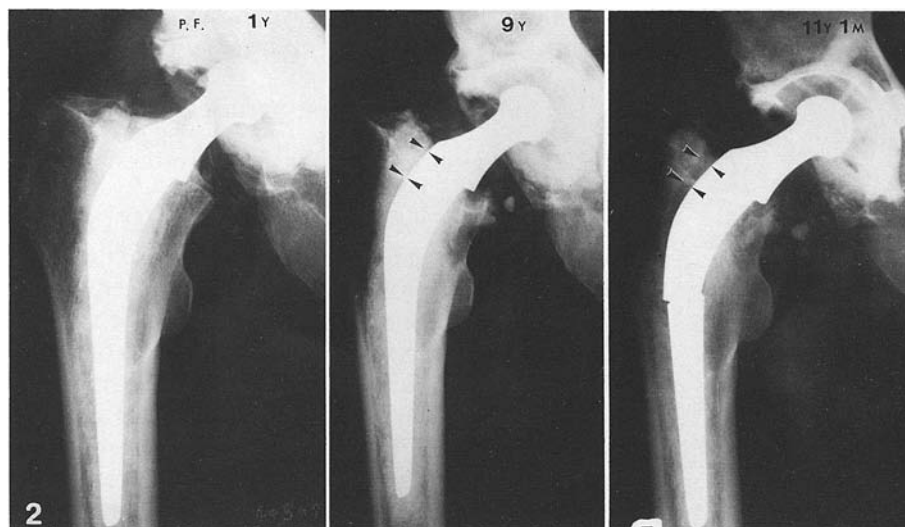
Stem position as well as radiographic aspects are reported in Table 2. The common features in all cases were a progressive resorption of the medial side of the proximal femur and varus bending of the stem

**Fig. 2.** Progressive resorption of the calcar femoris in a Charnley THR 9 years after insertion, varus bending of the stem (*arrows*) and fracture of the stem 2 years and 1 month later

(Figs. 2 and 3); fracture of the cement was a less constant finding.

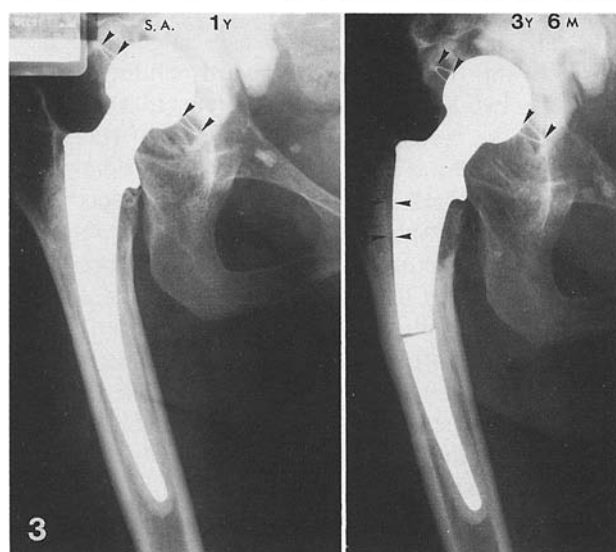
**Fig. 3.** Resorption of the calcar femoris and wear of the cup was observed in a Mueller THR 1 year after insertion; varus bending (*arrows*) and fracture of the stem 2 years and 6 months later. Wear of the cup is also progressed (*small arrows*)

In Mueller total hip replacements wear of the cup was the more constant finding, in accord with the very high quantity of polyethylene particles found in the tissues; metal particles in these cases are the result of fretting or polishing of the fracture surface, therefore they are produced when the process is far advanced and the stem already broken.

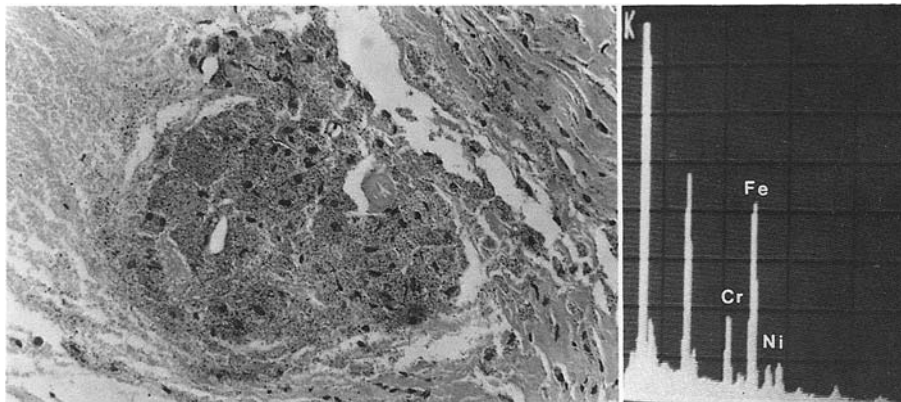
Fig. 4. Macrophages loaded by opaque, stainless-steel particles. On the left side an amorphous material is present; on the right a well organized connective tissue. X-ray micro-analysis was performed on the same section after the coverslip had been removed and the specimen observed with SEM (HE \times 190)

- small (less than 1 micron), opaque particles, which at microanalysis gave the characteristic pattern of the metal alloy of the stem (stainless-steel or Co-Cr) (Fig. 4);
- birefringent polyethylene particles (Fig. 5).

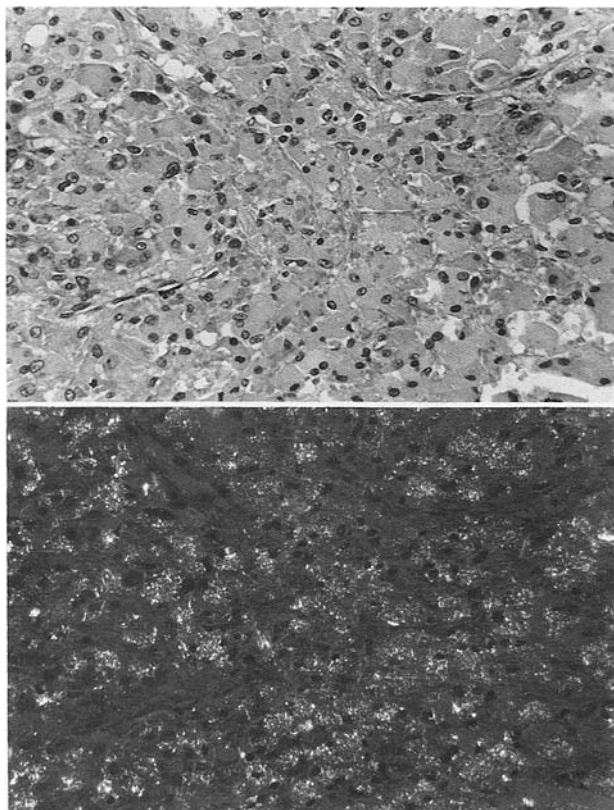
Fig. 5. Sheet of macrophages, apparently without cytoplasmic inclusions. In polarized light the same cells contain a large amount of small polyethylene particles (HE \times 190)

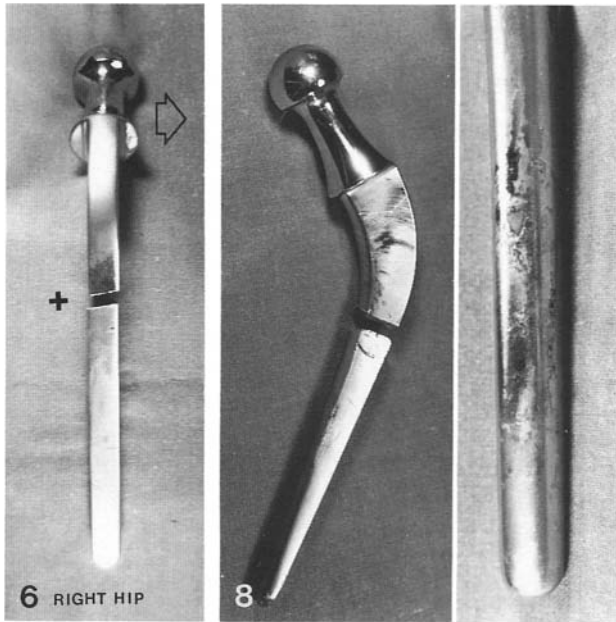
Fig. 6. M.D.: right Charnley prosthesis slope of the fracture line on the back of the stem (+) and forward bending of the proximal fragment

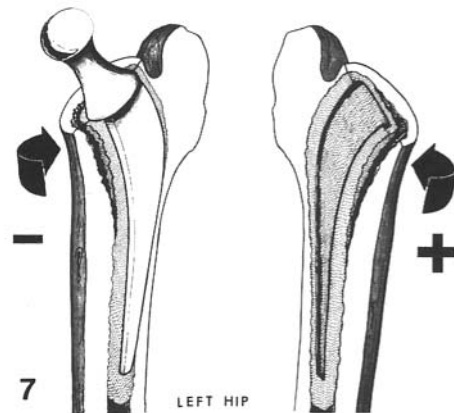
Fretting was evident on all proximal stem fragments (Fig. 8), while pitting corrosion was observed exclusively in stainless steel prostheses (Fig. 9). The extension of the corroded area is given in Table 3; it can be observed that corrosion occurred mainly in the distal stem fragment (Fig. 7), while the proximal showed extensive involvement only in one case. In

Fig. 7. Diagram illustrating the mechanism of forward and backward bending when the loss of bone stock extends anteriorly or posteriorly

Fig. 8. Failed stem: fretting is evident on the proximal fragment, while areas of pitting corrosion are observed on the distal stem

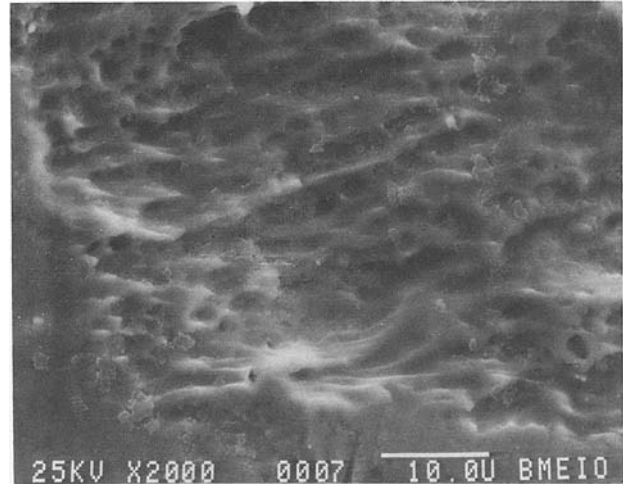
Fig. 9. Pitting corrosion of a stainless-steel stem (SEM $\times 1700$)

Corrosion has been cited as a possible cause of crack propagation leading to the fracture of the metal [5], however the aspect that is of interest here is the corrosion as a source of metal particles in the early stages of proximal loosening. Corrosion was observed mainly on the distal stem fragment, which in this type of loosening remains firmly anchored in the bone; when corrosion was observed in the proximal fragment, fretting was superimposed, therefore corrosion precedes fretting of the stem against the cement and, in time sequence, it is the first source of metal particles.
