# Design, defects and durability

## Cyclic Response of a 3D Printed Concrete Shear Wall Made with Concrete Extrusion

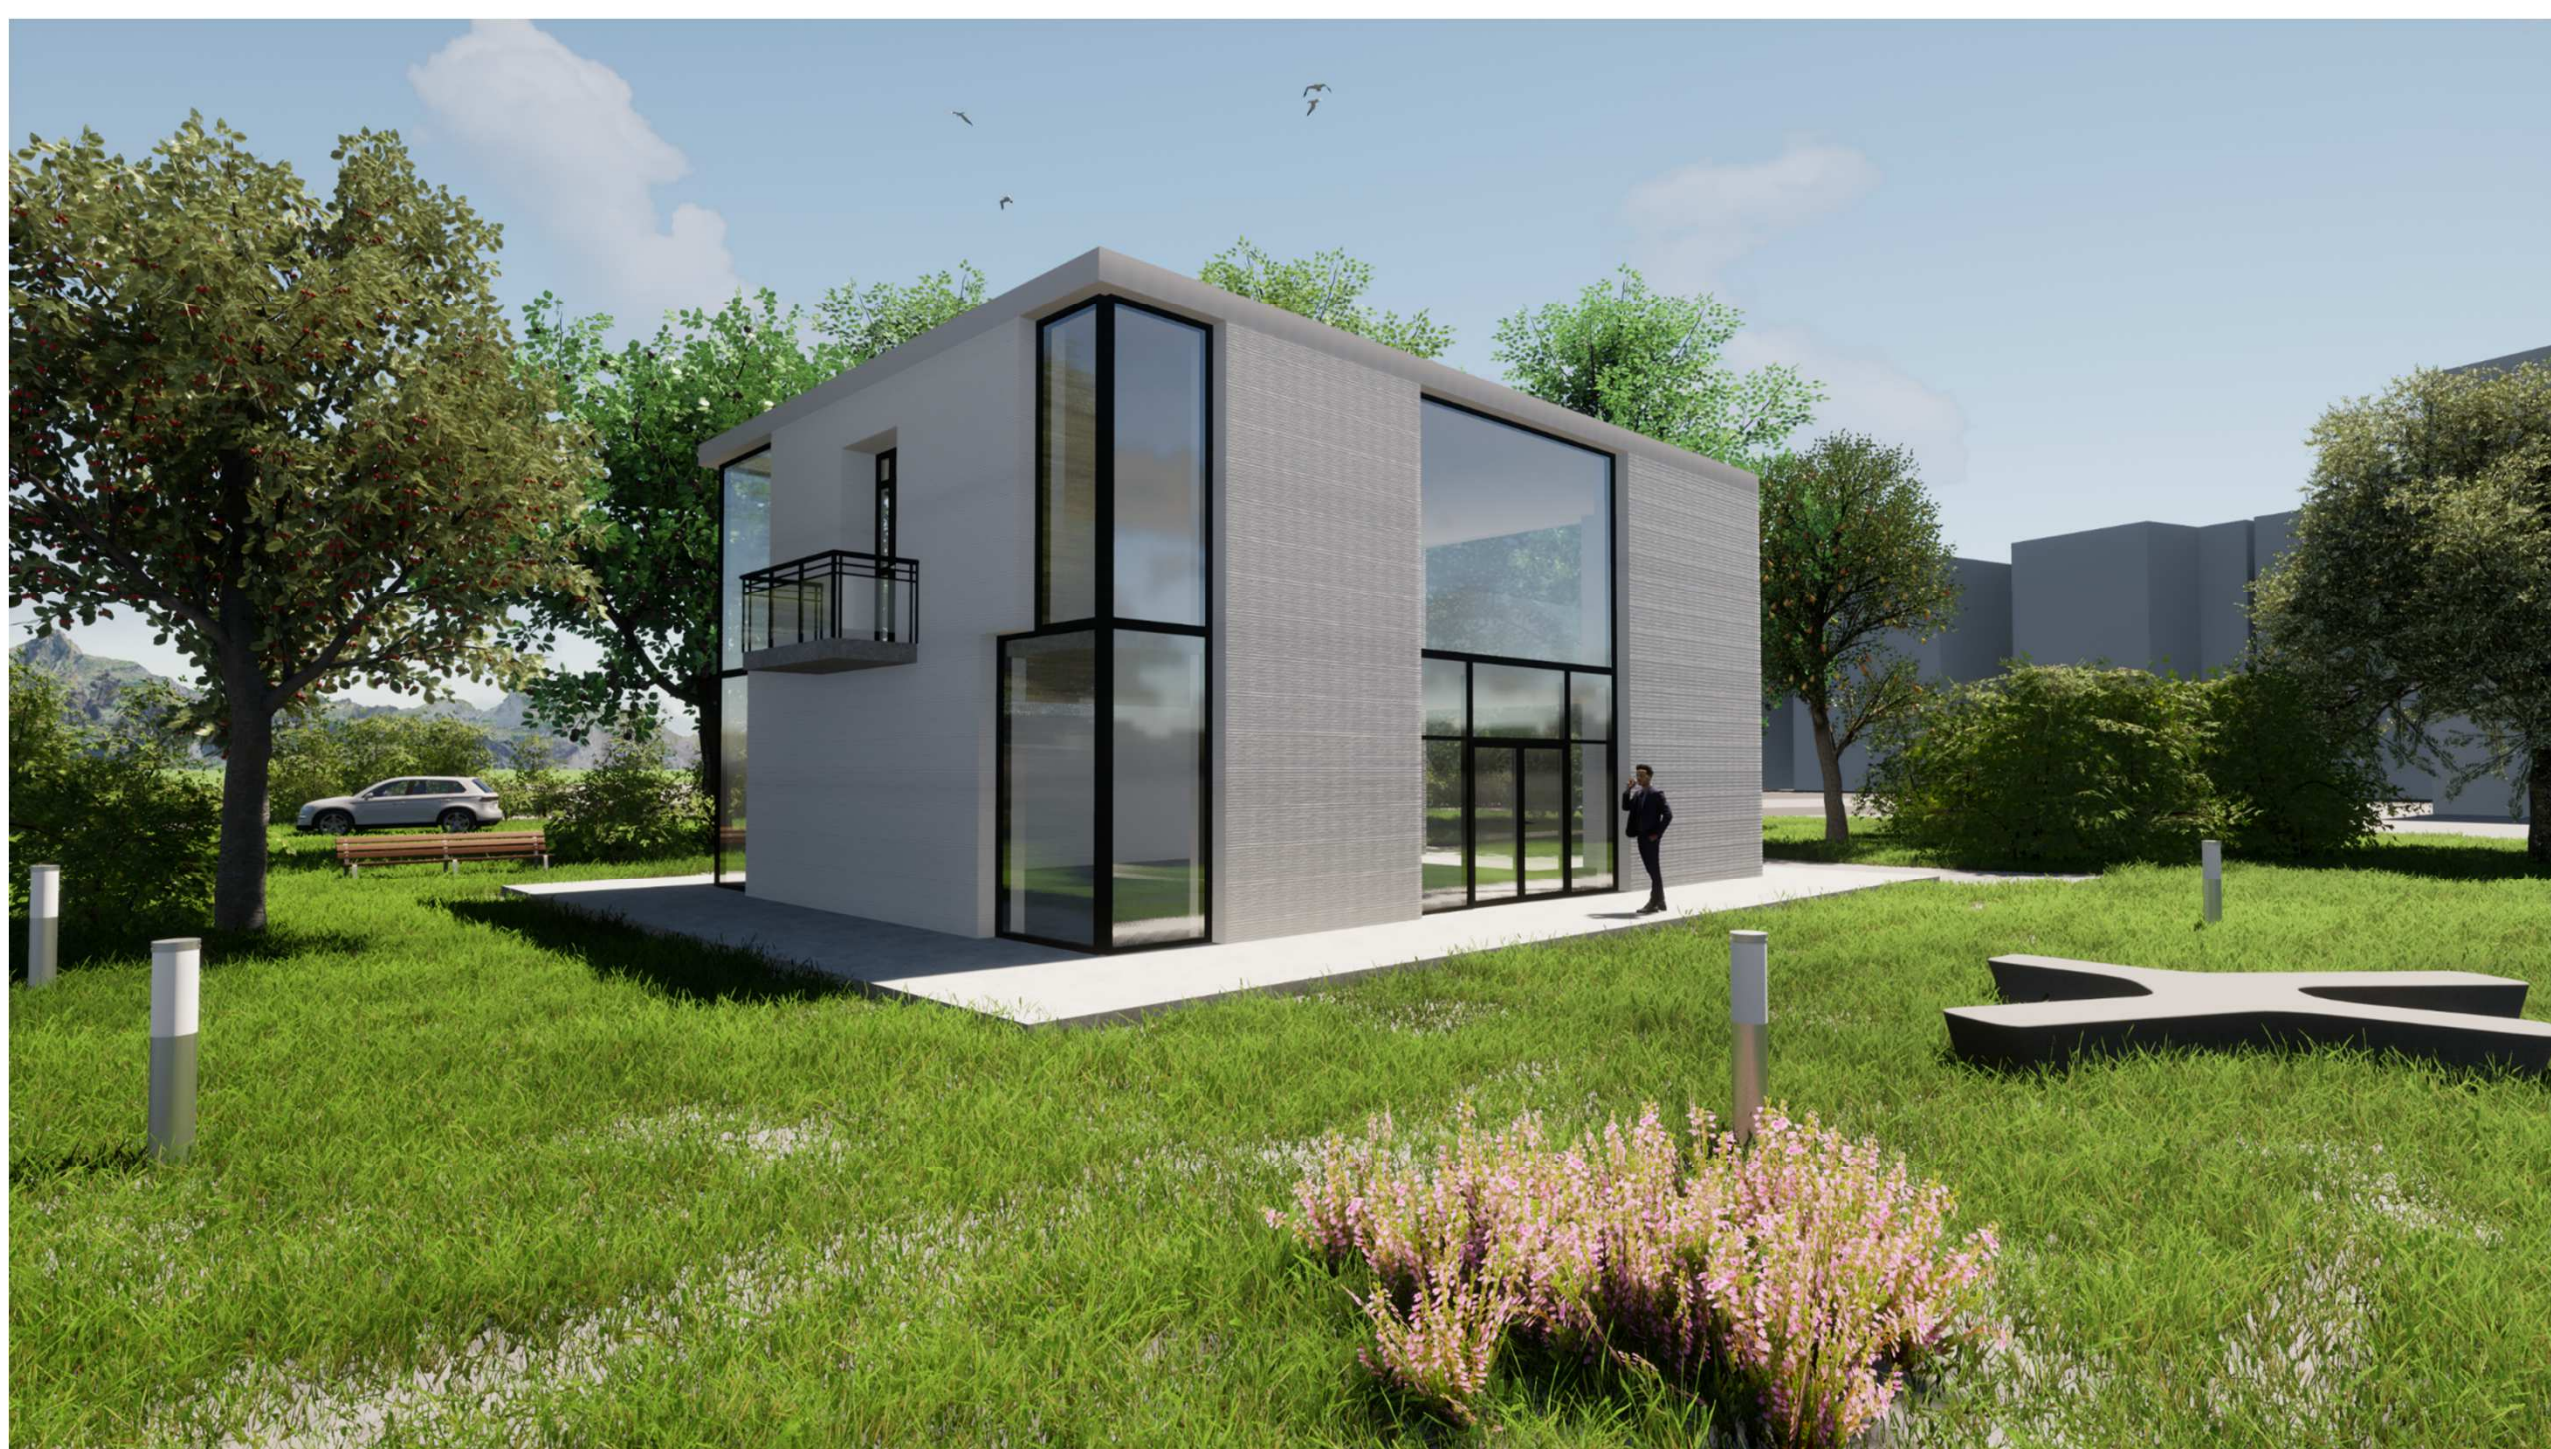
Figure 1. Two storey 3D printed concrete building prototype

Within this study, the attention is focused on the extrusion process. The proper control of the material properties and of the printing process is essential in view of the printing of low-rise building. The design of a 3D printed concrete wall to be applied in modular constructions of low rising building in seismic prone areas is described. The aim is to identify the main thermal, geometrical, mechanical parameters and investigate its structural performance. A critical discussion of the experimental results is presented. Figure 1 shows a two-storey 3D printed concrete building prototype taken as an example.

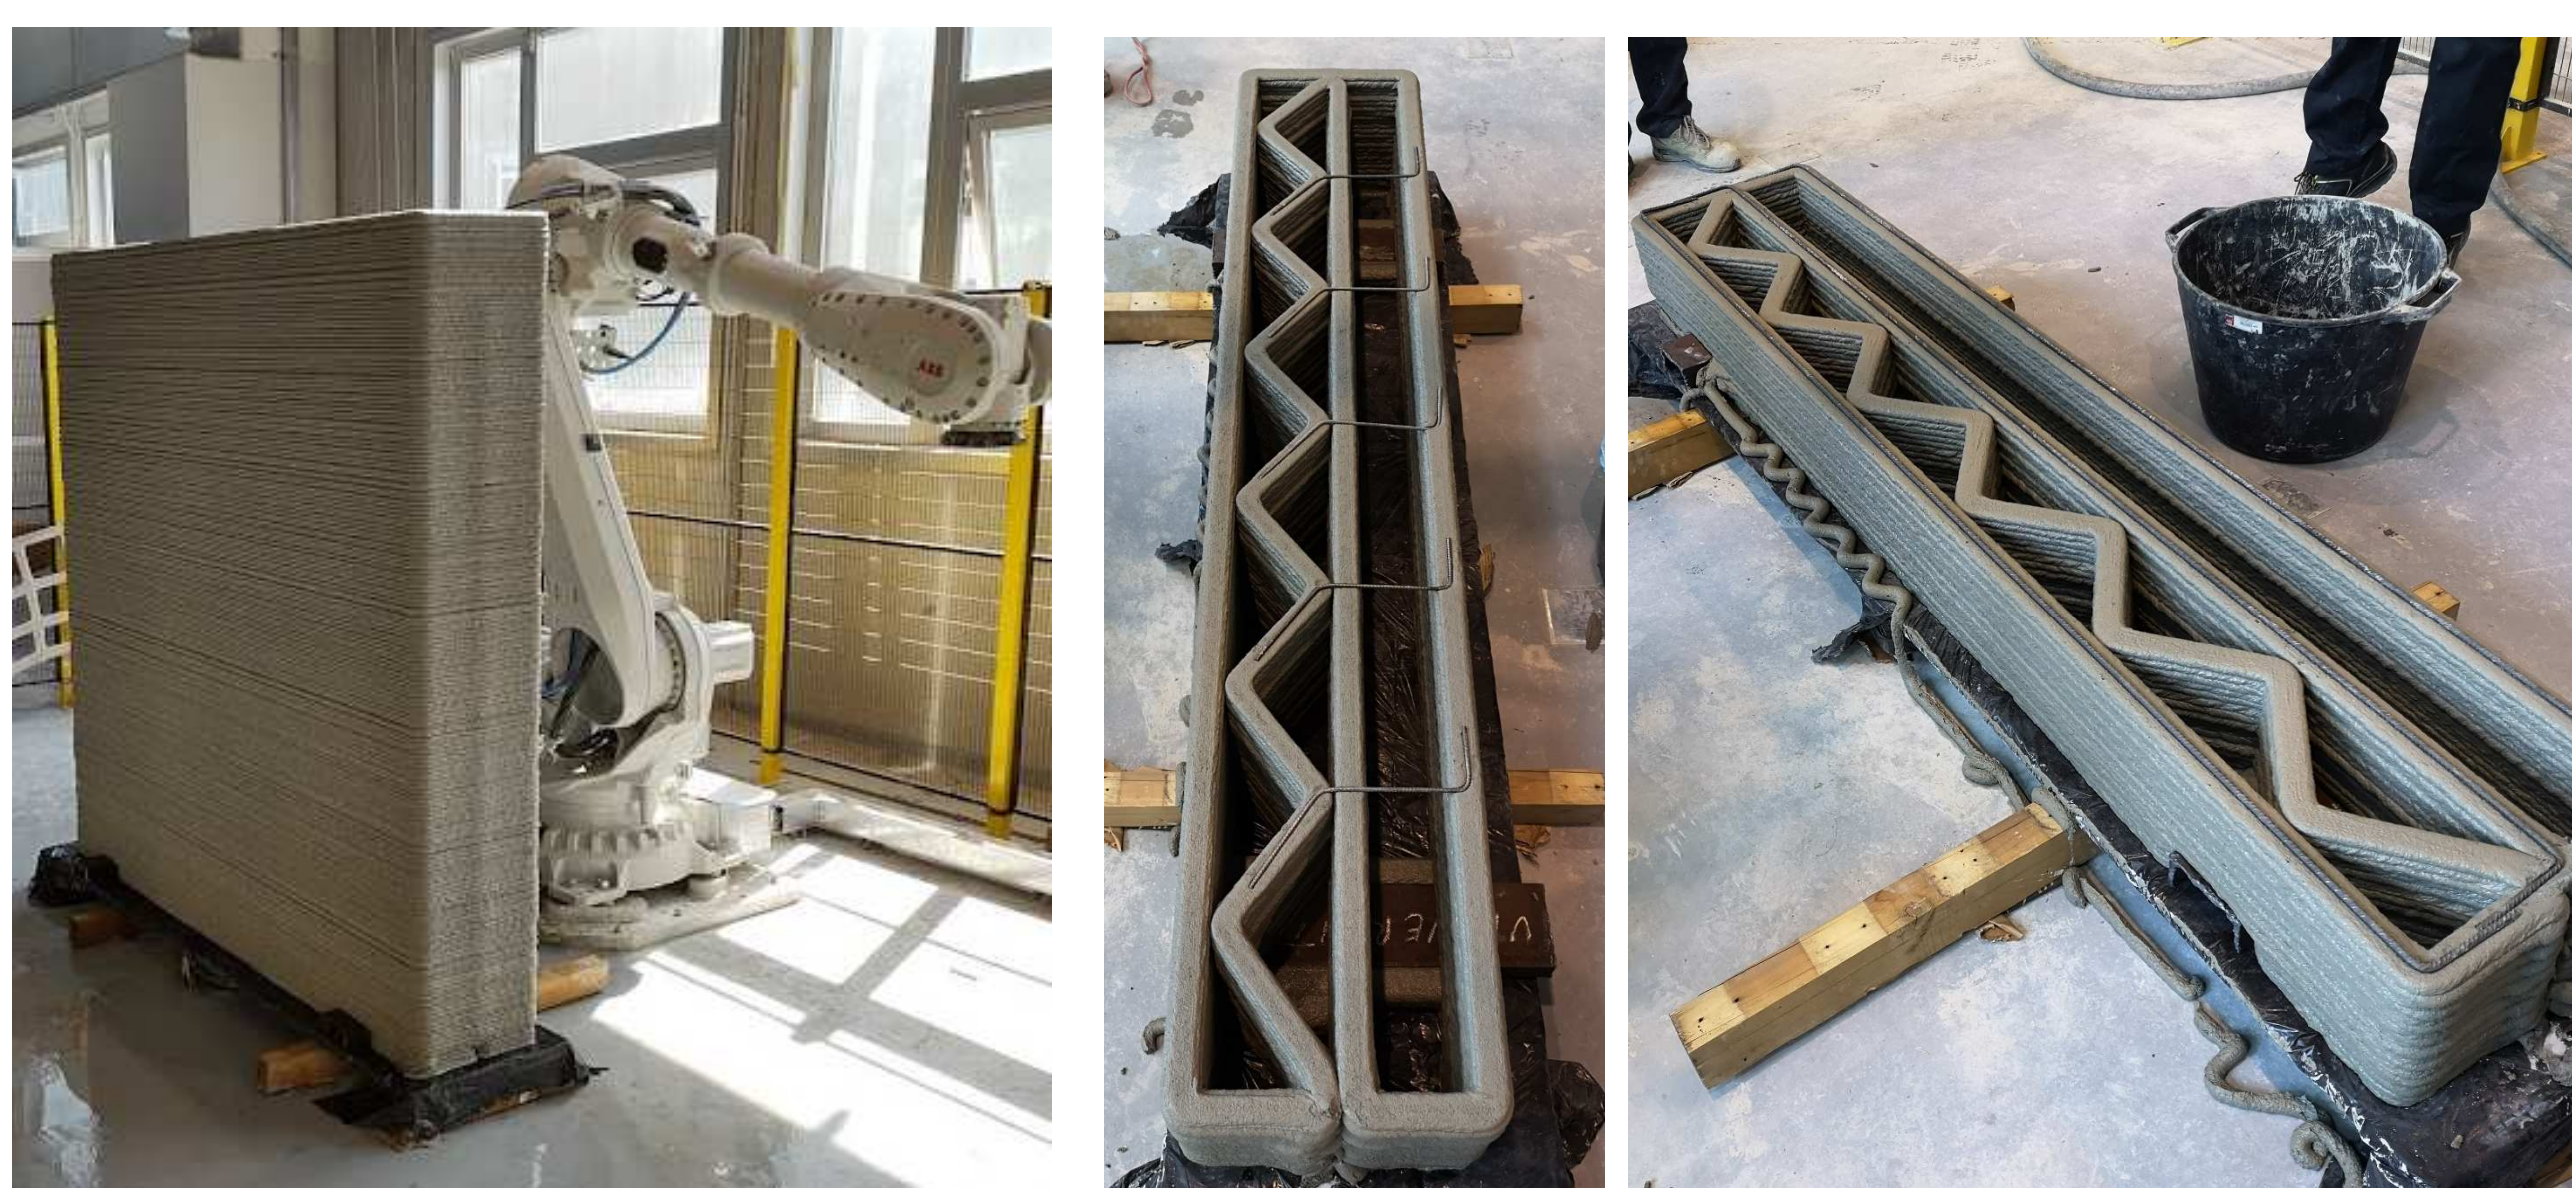
Figure 4. Unreinforced 3DPC wall: printing process.

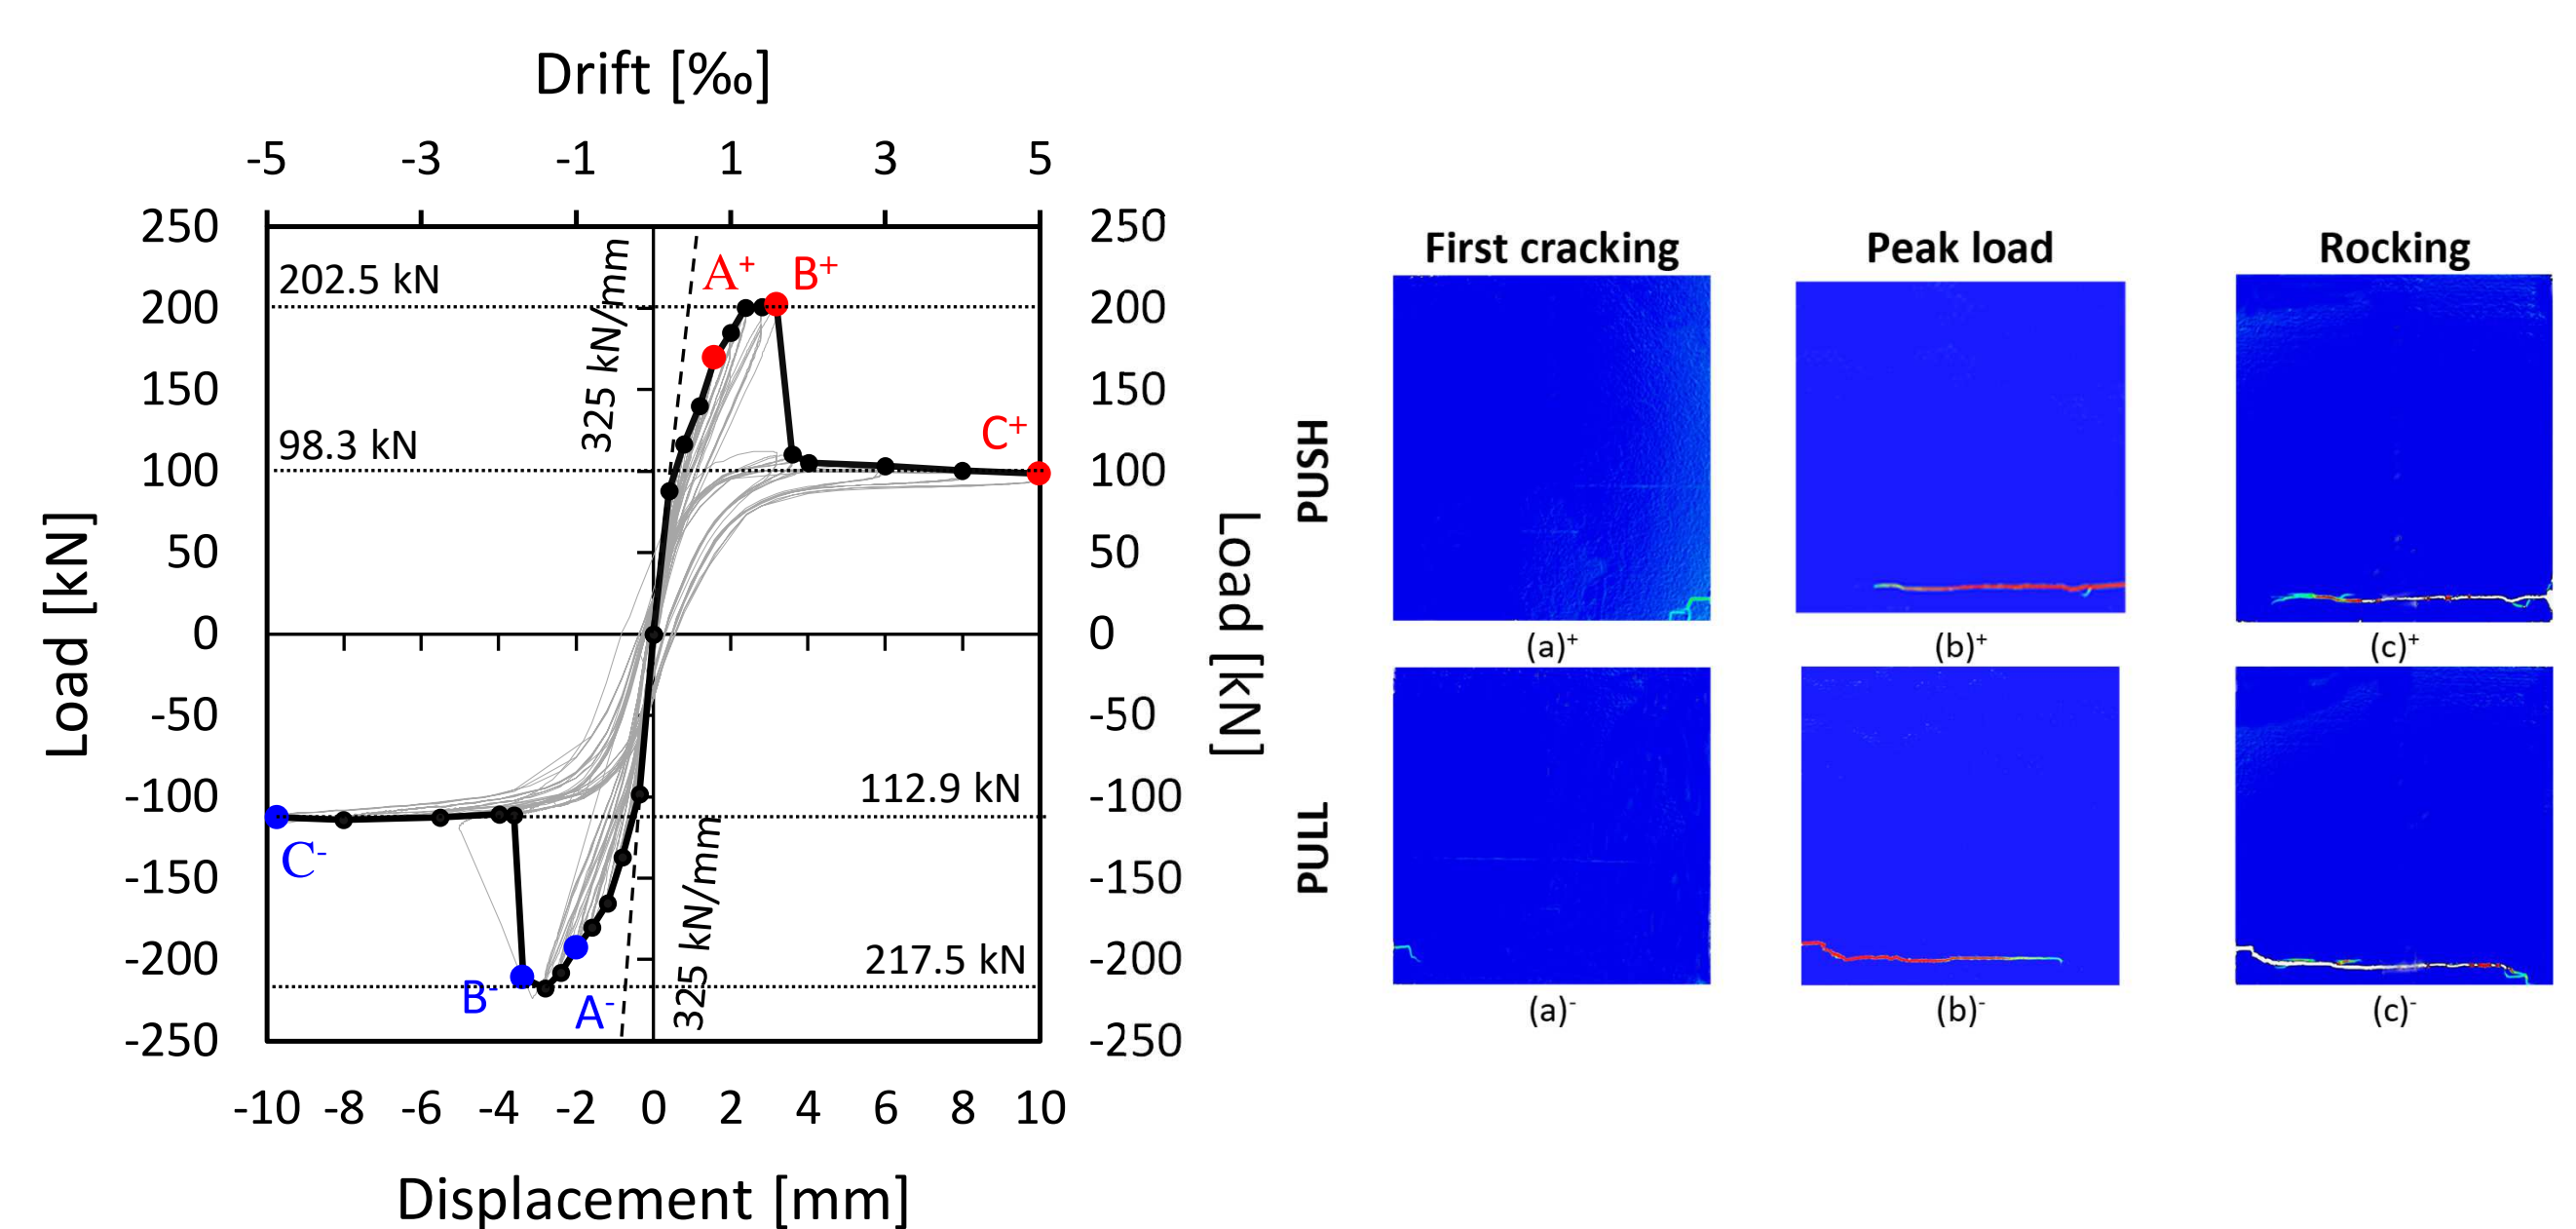
Figure 6. Strain field from DIC: (a) first cracking at 0.8‰ drift; (b) critical cracking (peak load) at 1‰ drift; (c) cracking associated to rocking mechanism up to 5.0‰ drift.

Once the maximum tension strength was reached, the wall showed a brittle failure with a horizontal flexural crack running at the interface of two filament layers. First cracking occurred during the push phase (point A<sup>+</sup>) at a load of 192.6 kN and a drift of 0.8‰. On the reversal of loading, cracking appeared during the pull phase (point A<sup>-</sup>) at a load of -192.9 kN and a drift of 1‰. A critical crack, then, developed along the entire cross section (points B<sup>+</sup> and B<sup>-</sup>) at a load of -217.5 kN and a drift of -1.6‰. After the cracking, a rocking mechanism followed (points C<sup>+</sup> and C<sup>-</sup> in Figure 6).
