Experiences from the Northern Italy 2004 earthquake: vulnerability assessment and strengthening of historic churches

ABSTRACT: This work is about the lesson learnt from the analysis of the damages caused to some churches by the strong earthquake, which struck Northern Italy in the year 2004. Focus is paid to some mechanisms which are not well known in the literature: the excessive and differential rocking of neighbouring transverse arches, the differential deflection of single leaf vault rings, the tie over-tension induced by the transverse arch rocking. In the paper, the structural solutions appositely studied to repair and to reduce the structure seismic vulnerability of these buildings are presented. Among these solutions: internal perimeter ties, lightweight wooden roof box structure, lightweight spandrel ribs are illustrated.

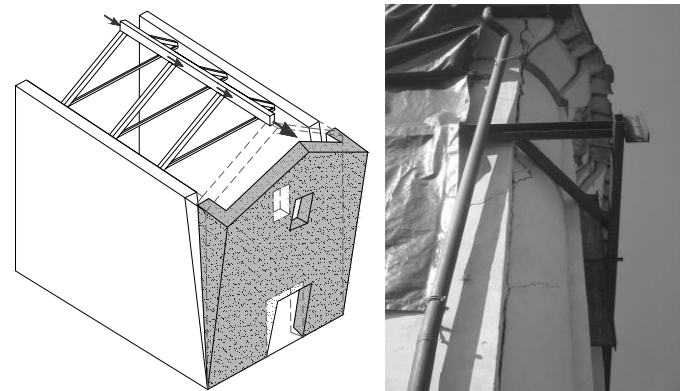
Overturning of the main façade was often observed during the survey campaign (Figure 1, Table 1). This collapse mechanism was caused by the seismic action of the wall and by the possible lateral seismic thrust of the roof beams. Provided that wooden roofs are usually unconstrained against lateral movements, the latter contribution to the toppling action was quite relevant in most of the analyzed churches.

The onset of the overturning mechanism is underlined by the development of cracks extending at the wall edges and progressively reducing their width from the top to the footing of the building. The cracks can be vertical or angled, depending of the degree of anchorage to the perimeter walls. However, it is worth noting that, the measured crack angle was always very small, thus the stabilizing contribution of the lateral walls was almost negligible in most cases.

Figure 1. Overturning of the façade induced by the roof seismic thrust.

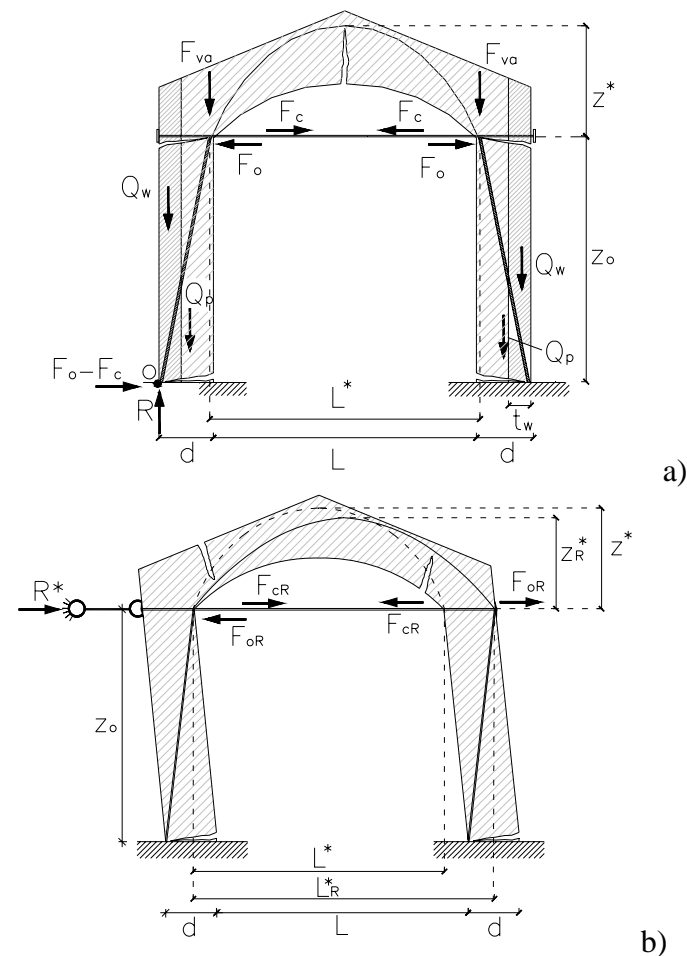
on their shape and massiveness (Figure 2a, Giuriani and Gubana 1993 and 1995). As a result the possible ties are required to confine the arch thrust portion, which exceeds the buttress action. The proportion of the confining contribution mainly depends on the structure geometry and tie pretension. Conversely, in the case of rocking, the resisting mechanism significantly modifies (Figure 2b, Giuriani et al. 2007 and 2008). The crack pattern is characterized by two large horizontal cracks developing at the abutment bases and two cracks opening at the diaphragm arch springing (Figures 2b, 3 and 4). The location of the cracks depends on both the structure geometry and the local resistance.

plus the thickness of the abutment (d) (Giuriani et al. 2007, 2008). For typical case studies the ratio d/L^* was observed to range between $0,15 \div 0,2$, thus when shifting from rest condition to rocking the arch thrust could be $30 \div 40\%$ larger than the thrust at rest condition.

Figure 2. Transverse arch resisting mechanisms under a) vertical loads (rest condition) and b) horizontal loads (case of full rocking, Giuriani et al. 2008).

The abutment buttress action dramatically diminishes as the crack penetration progresses. In the case of full rocking, when the crack pattern is fully developed, no abutment buttress action can be accounted for, because the resisting ideal struts become parallel to each other. As a result, the arch thrust has to be entirely confined by the existing ties.

Furthermore, following the cracking triggered by the rocking motion, the span of ideal arch significantly increases and so does the arch lateral thrust (Figure 2b). The span of the ideal arch in rocking condition can be conservatively assumed to be equal to the span of the ideal arch in rest condition (L^*)

A simplified method was proposed in Giuriani et al. (2007 and 2008) for the evaluation of the collapse multiplier and the tie tension in the case of either over resistant or weak ties. The seismic collapse multiplier was evaluated by introducing an ideal additional horizontal constraint at the tie level, and by enforcing that its reaction force R^* was nil (Figure 2b).

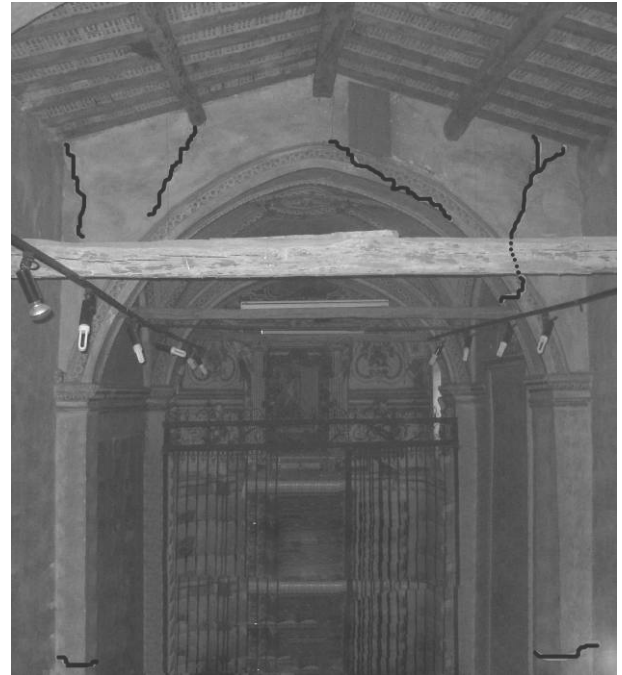
Figure 3. Madonna della Rocca Church, Sabbio Chiese, Italy. Transverse arch crack pattern induced by the seismic action.

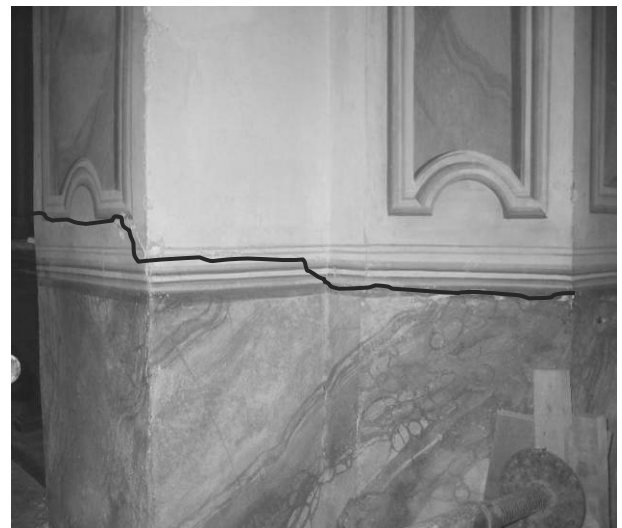
Figure 4. Detail of the horizontal crack pattern at the transverse arch abutment base induced by the seismic action.

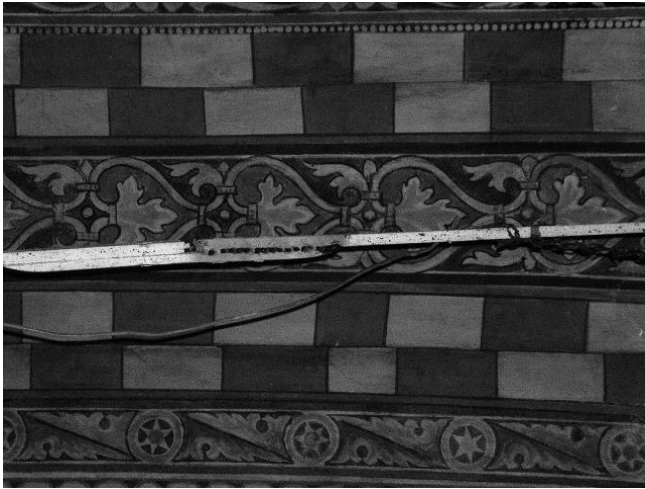
Given this foreword, the failure of the existing ties in San Antonio Church (Roè Volciano, Figure 5) was interpreted as a consequence of the onset of the transverse arch full rocking mechanism. In some

Figure 5. Detail of the welded tie rod in San Antonio Church (Manerba, Brescia, Italy). The tie rod collapsed during the 2004 earthquake.

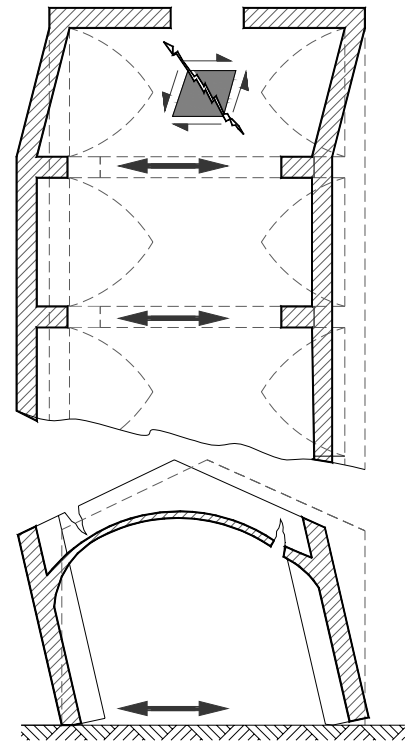
The largest differential displacements are usually experienced by the first and last bay transverse arches. As a matter of fact, the façade rarely undergo rocking, unlike the nearby transverse arch; and the triumphal arch is typically much stiffer than the neighboring transverse arch. This way, the vaults covering the first and last bays are subjected to shear distortion. When differential rocking is severe, shear distortions can be remarkable and diagonal cracks may form in the vault ring (Figure 6). The damage is more severe for thinner vaults, like the single leaf vaults. In the case of very strong earthquake differential rocking may even cause the collapse of the vault.

Figure 6. Crack pattern induced by the differential transverse arch rocking. Differential rocking, which is maximum in the first and last bay of the nave, is the result of the different stiffness of the transverse arches.

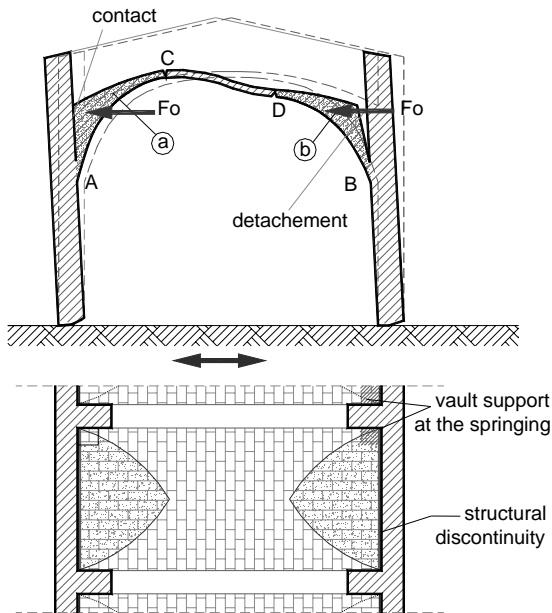
When subjected to earthquake loads, the nave vaults also experience differential deflection of the vault groins (Figure 7). Traditional masonry groins are connected to the perimeter walls at the impost, whereas the vault rings are built adjacently to the perimeter walls. This result in the structural discontinuities shown in Figure 7.

When subjected to the seismic actions F_0 illustrated in Figure 7, groins *a* and *b* rotates counter-clockwise around points A and B. the vault groin *a* pushes against the perimeter wall, whereas groin *b* detaches from the perimeter wall and the discontinuity width increases for increasing seismic actions. As a result, the central portion of the vault is subjected to concentrated differential deflection. The mechan-

Figure 7. Differential flexural mechanism of the groins of the single leaf vaults.

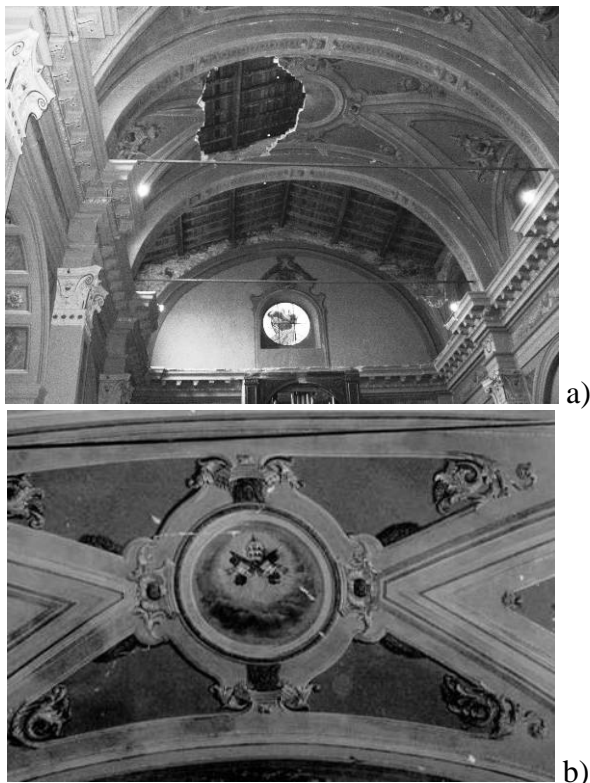
Severe shear distortions induced by differential rocking and differential deflection of the vault were recognized as the major causes of total and partial collapse of the single leaf barrel vaults of the first and second bay of the main nave of San Pietro Church in Roè Volciano Brescia (Figure 8).

Figure 8. S. Pietro Church in Roè Vociano, Brescia, Italy: a) total and partial collapse of barrel vaults of the first and second bay of the main nave, and b) crack pattern induced by

the differential rocking and deflection of the single leaf groin vaults.

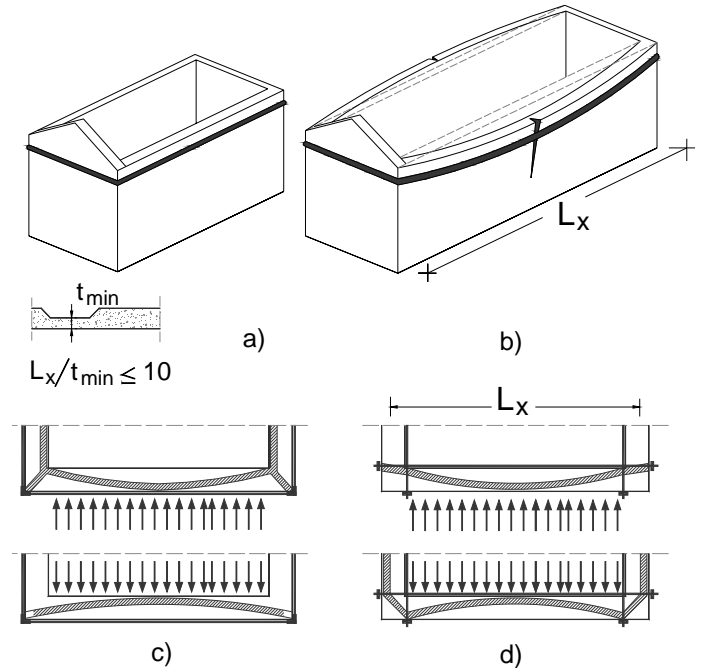
Figure 9. Introduction of internal or external perimeter ties.

When the tie confining effect is insufficient the tie system must be strengthened or replaced. This operation is usually done by placing a new external tie system, provided that the embedment of the ties within the wall width would require expensive and difficult drilling works (Figure 9a).

The static scheme of the external perimeter tie system is illustrated in Figure 9c. For the solution to be effective, the perimeter ties must confine the resisting ideal horizontal arch, developing within the masonry wall width, at the springing. This solution was applied in San Pietro and Paolo Church, Preseglie, Italy (Figure 10).

The same confining action can be effectively obtained by adopting an internal tie system, hidden on top of the nave mouldings (Figure 9d). This solution has the obvious advantage of being hidden from the sight, but it may also serve in case of irregular or preciously decorated external walls. The confinement of the resisting natural arch can still be obtained, provided that the inclined compressed strut

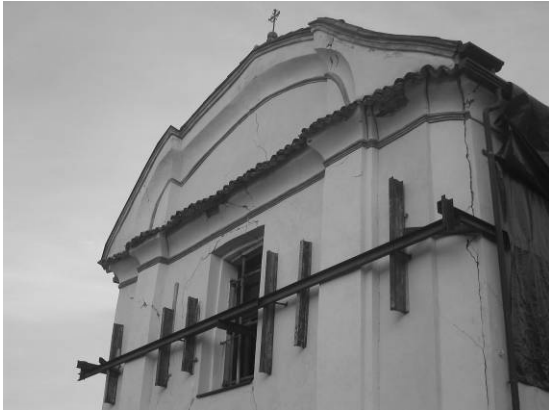
Figure 10. San Lorenzo Church (Clibbio, Brescia, Italy): external perimeter ties adopted as safety emergency provisional solution following the 2004 earthquake.

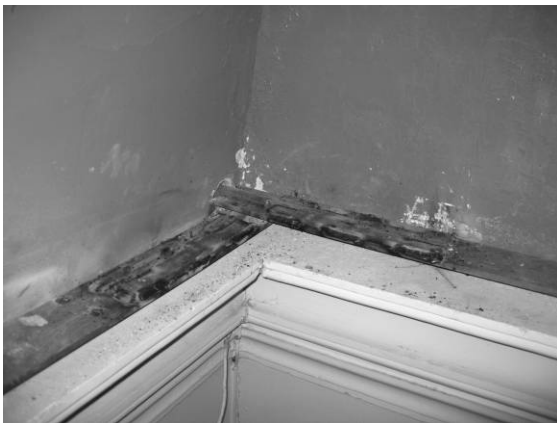
Figure 11. Detail of the internal perimeter ties hidden over the nave moldings in San Pietro Church, Roè Volciano, Italy.

forms in the masonry intersections (Figure 9d). This solution was applied in San Pietro Church, Roè Volciano, Italy (Figure 11).

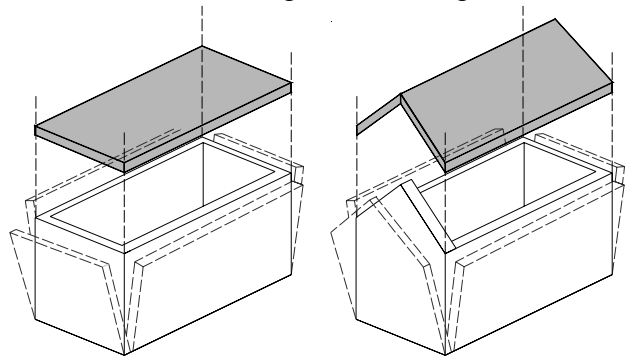
Figure 12. Floor and roof box structure preventing perimeter walls overturning.

Roof box structures behave like floor diaphragms, forming a sort of lit to the underlying masonries, thus preventing the perimeter wall overturning (Figure 12). The roof pitches are transformed into folded plates, which gather and transfer the horizontal seismic actions of the lateral walls, the diaphragm-arches and the roof to the shear resisting walls.

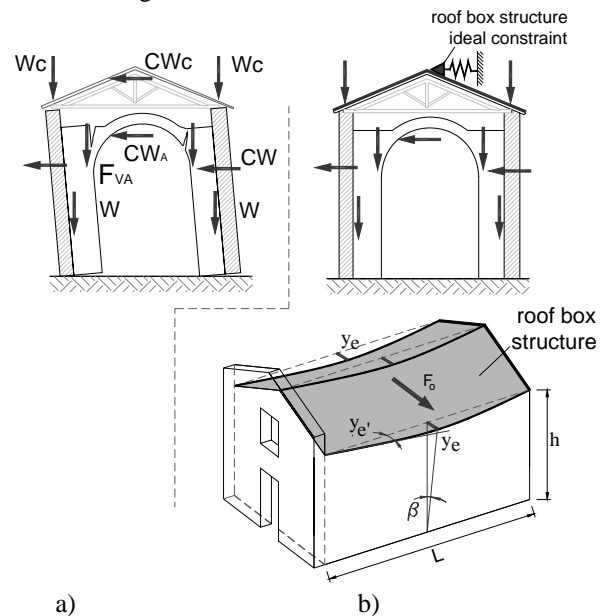
Figure 13. Structure behavior a) prior to and b) following the introduction of the roof box structure preventing excessive and differential transverse arch rocking.

The roof box structure introduces an elastic constraint along the roof ridge, whose stiffness depends on the horizontal flexural deformability of the roof box structure (y_e , Figure 13b). The box structure can be proportioned in order to confine the maximum mid span displacement (y_e) and the masonry wall drift (β), as well as to limit the shear distortion near the supports (y_e' , Figure 13b). This way the box structure can be an effective solution to the excessive and differential rocking of the diaphragm arches.

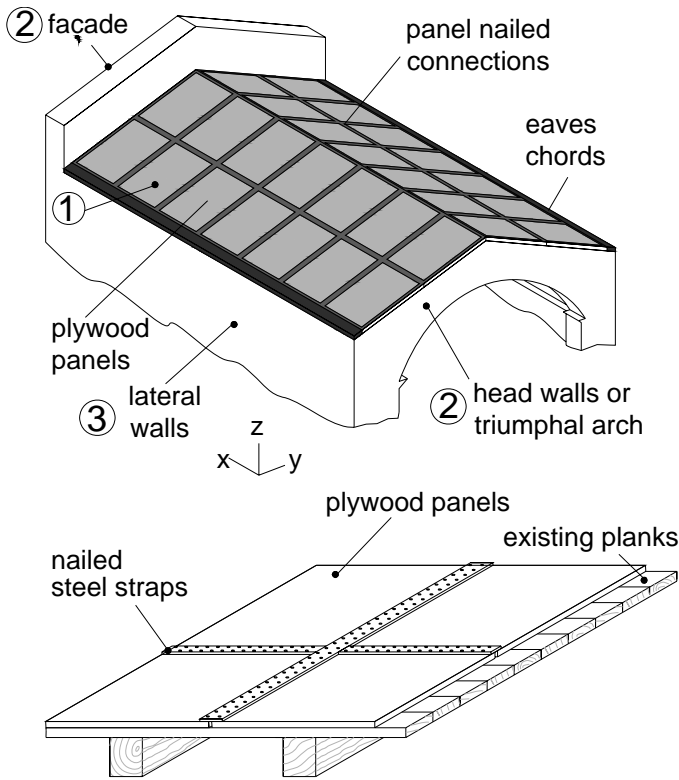
Figure 14. Wooden roof box structure by means of overlaying nailed plywood panels. Principal structural component and detail of the plywood panel assembly.

The main structural elements composing the roof box structure are: the pitch-panel (1), the eaves chords (c_{13}), the head gables (2) (Figure14).

The wooden lightweight box structure proposed in Giuriani and Marini (2008) were adopted. With the proposed technique roof diaphragms were obtained by placing overlaying plywood panels on the existing wooden roof pitches (Figure 14). Plywood panels were connected to each other by means of nailed steel flanges. The whole pitch diaphragms were nailed to the perimeter steel eaves chords, and to both roof rafters and masonry walls by means of steel studs and vertical anchored bars.

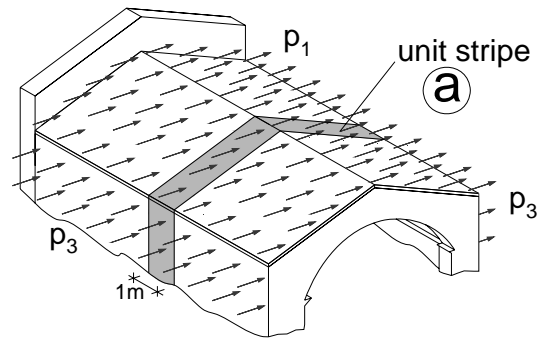
Figure 15. Seismic action distribution

By reference to the load distribution shown in Figure 15, in order to analyze the roof box structure behavior, a two step approach was adopted. In the first step vertical and horizontal idealized additional constraints, having r_{1z} and r_{1y} reaction respectively, were introduced along the roof ridge line (Figure 16). In the second step these provisional constraints were removed and their reaction forces (r_{1z} and r_{1y}) were backed out.

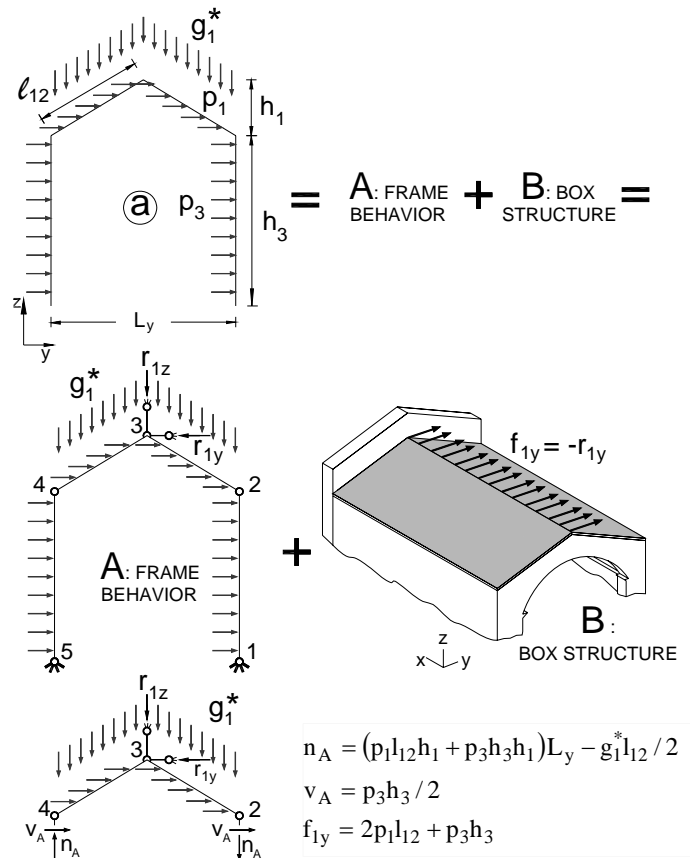
Figure 16. Structural behavior. a) Frame action and b) box-structure undergoing horizontal ridge loads.

like a frame undergoing the seismic actions (case A-Figure 16). In this phase, significant uplifting vertical force per unit length n_A may arise along the top lateral wall. These possible tensile forces must be balanced by the wall self-weight, through anchored bars suitably embedded and distributed along the crowning masonries.

In the second step, the additional ridge constraint reactions were backed out with forces of equal intensity and opposite sign (f_{1y} , f_{1z} in Figure 16). Provided that Frame A would be a free mechanism with respect to the horizontal force f_{1y} , for the balance to be restored, the roof box-structure must sustain these forces (case B, Figure 16).

The expressions of the most significant internal forces are shown in Figures 16 and 17. The eaves chord cross section was proportioned to resist the eaves chord maximum axial forces (F_{13}); whereas the pitch panel thickness, the panel mutual connection, and the diaphragm connections to both the head gables and the eaves chords were proportioned to resist the maximum shear flow q_1 .

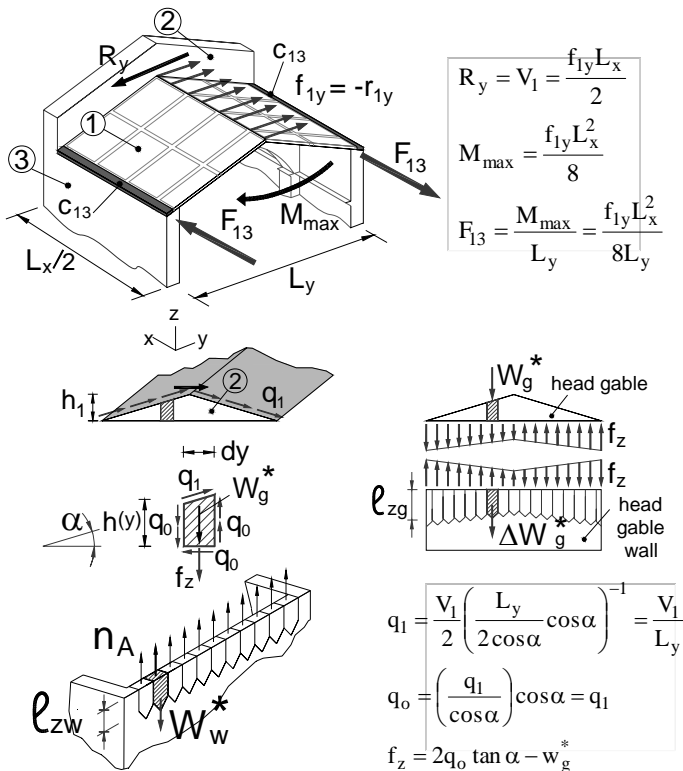
Figure 17. Simplified schemes for the evaluation of the force distribution in the box structure.

is based on the assumption that the in-plane bending moment and the shear force be decoupled and resisted by the chords and panels, respectively (Bruhn 1973). Considering a gable roof, the ribbed panels box structure is assumed to behave like a simply supported beam undergoing distributed forces f_{1y} , in which the eaves chords withstand the global horizontal bending moment, and the pitch panels resist to the shear forces induced by the horizontal load (Figure 17).

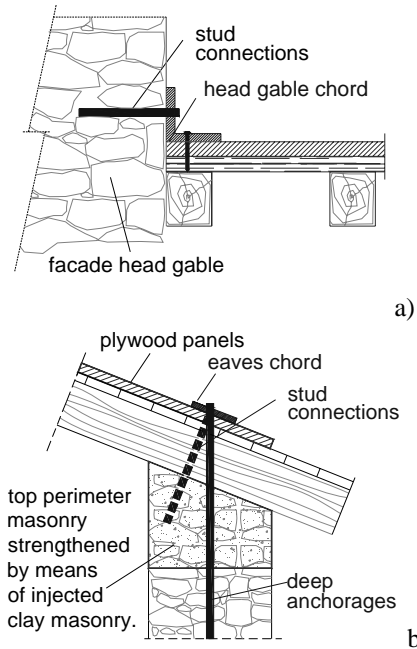
Figure 18. Detail of the connection a) to the facade head gable and b) to the longitudinal walls.

Horizontal and vertical steel stud connections were adopted to allow shear transferring to the shear resisting head gable and longitudinal walls, respectively (Figure 18). For the proportioning of the stud connection, mindful attention was paid to the reduced shear resistance of the masonry wall crown caused by the lack of vertical confining load. To increase the stud connection resistance, strengthening

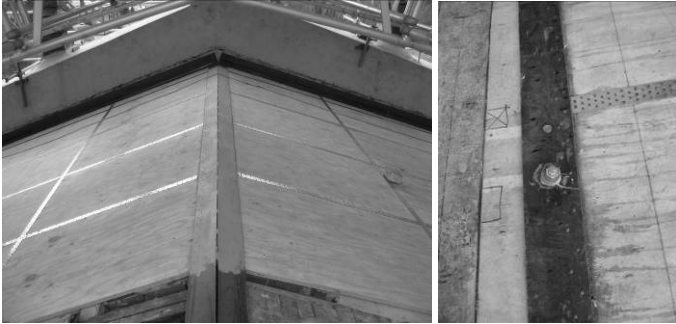
Figure 19. General view of the anti-seismic plywood roof box structure in San Pietro Church (Roè Volciano, Brescia, Italy) and detail of the eaves chord connected to the underlying masonry by means of steel studs and deep anchorages.

The lightweight wooden box structure applied for the anti-seismic retrofit of the San Pietro church is shown in Figure 19.

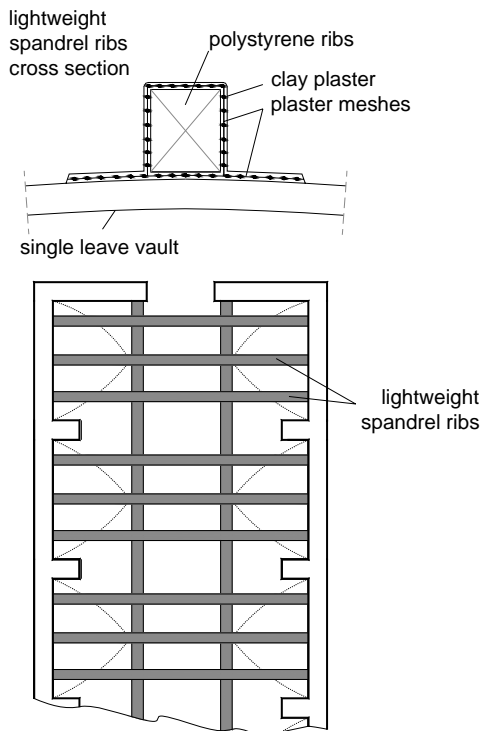
Figure 20. San Pietro Church (Roè Volciano, Brescia): distribution of the lightweight spandrel ribs along the extrados of the nave vault and detail of the spandrel rib cross section.

The lightweight spandrel ribs tubular cross section is shown in Figure 20. The resisting cross section is made of clay mortar reinforced with plaster meshes. The inner lightweight core is made of polystyrene elements.

In San Pietro Church, spandrel ribs were placed along the vault extrados as shown in Figure 20. The construction phases are briefly illustrated in Figure 21.

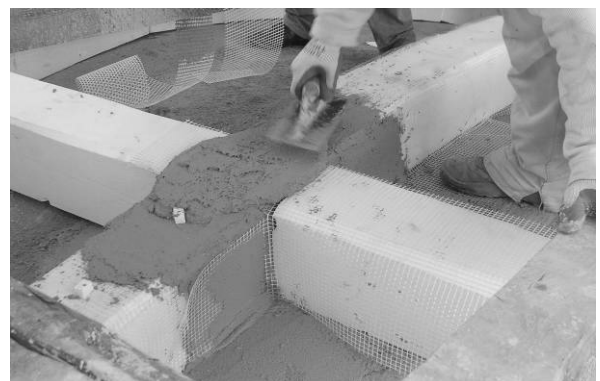
Figure 21. Light spandrel ribs construction phases: a) a layer of plaster mesh is placed overlaying the vault extrados; b) the mesh is covered with a layer of clay mortar; c) polystyrene ribs are placed along the vault ring and covered by plaster meshes; d) a thin finishing layer of clay mortar is spread over the structure.

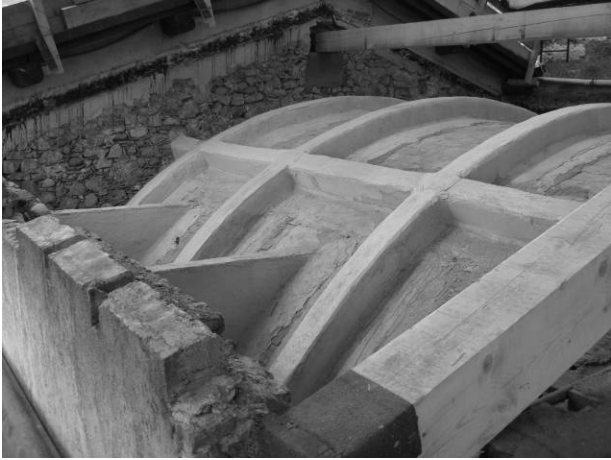
Figure 22. San Pietro Church (Roè Volciano, Brescia): light spandrel walls strengthening the single leaf masonry dome covering the presbitero.

The same technique was applied to strengthen the single leaf masonry dome covering the presbitery (Figure 22).

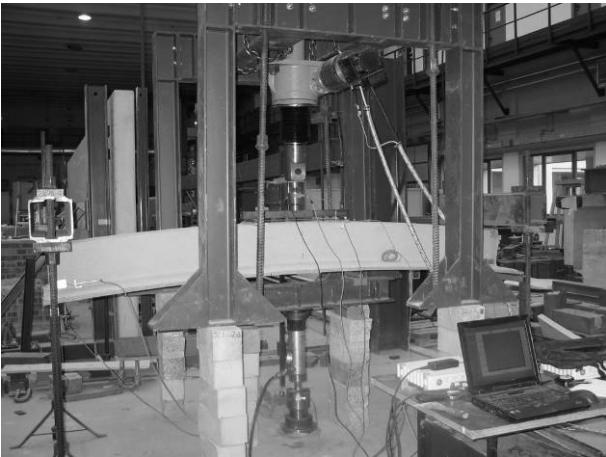
Figure 23. Experimental test on light spandrel walls (Pisa Laboratory, University of Brescia, Italy).

The efficiency of the proposed technique was also verified experimentally (Figure 23). The structure was subjected to cyclic, unsymmetrical load conditions. Good results were obtained both in terms of stiffness and strength (Giuriani et al. 2007).
