In-situ testing of the out-of-plane flexural behavior of hollow block masonry walls retrofitted with steel fiber reinforced mortar coating

Department of Civil, Architectural, Environmental Engineering and of Mathematics (DICATAM), University of Brescia, Italy

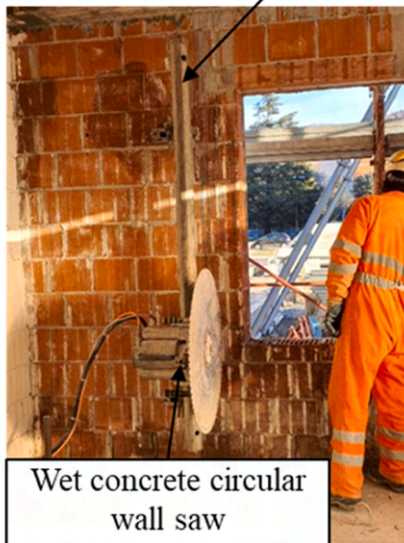
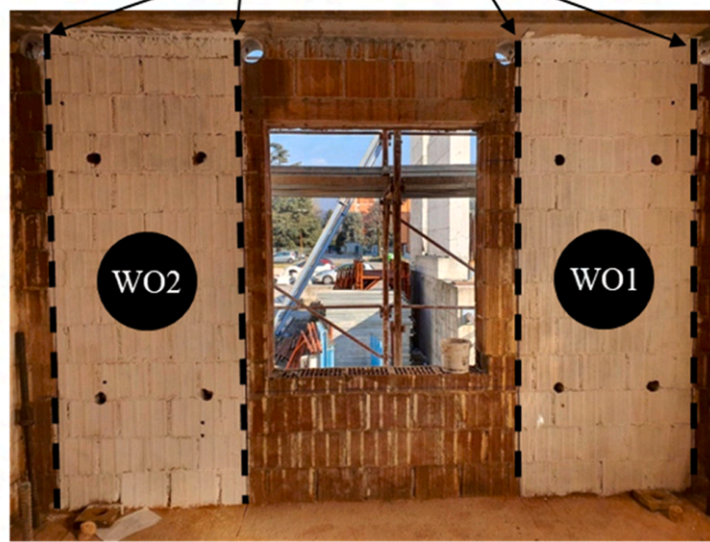
Fig. 2. Preparation of the one-way spanning walls (inside view).

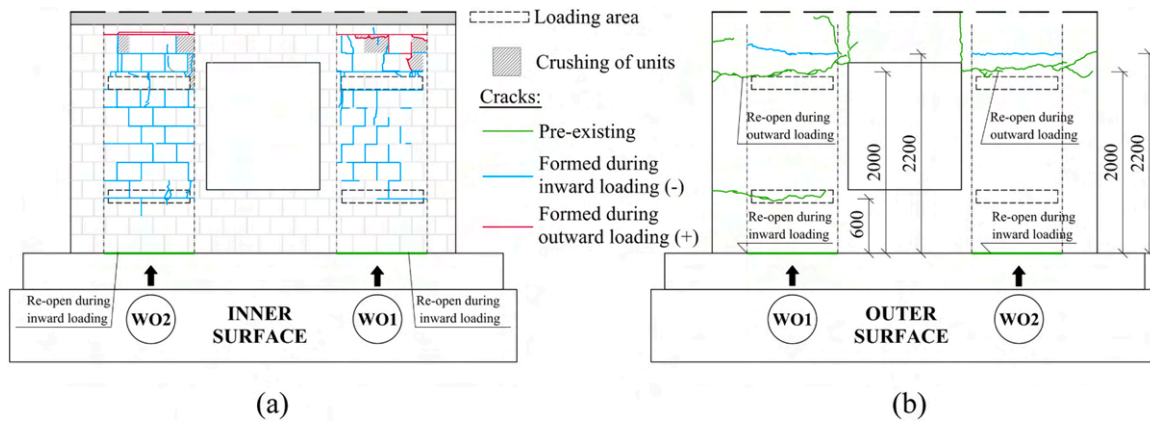
Fig. 8. Ultimate crack patterns detected on both the (a) inner and the (b) outer surface of the wall WO1 and WO2 (dimensions in [mm]).

better understand the wall’s behavior, it is worth considering also the crack patterns illustrated in Fig. 8. Prior to the test, the wall exhibited pre-existing cracks from earlier cyclic loading conducted on the full-scale building [23]. In particular, a horizontal crack at the wall base was due to global rocking of the building during previous lateral loading, while two horizontal cracks near the upper loading beams resulted from the building’s torsional response. At the time of OP testing, the base crack had closed completely, but the upper cracks on the outer surface remained partially open, with a residual width of about 0.1 mm. These were monitored by the potentiometer V4 on the

Under negative loading, a single horizontal crack (blue) formed on the coating surface (Fig. 8b), together with multiple cracks crossing mortar joints at mid-height (Fig. 8a). Repeated cycles resulted in clearly visible damage to the masonry units near the top of the wall, causing a sudden stiffness drop at a deflection of -2.0 mm. The horizontal blue crack widened significantly, from an initial width of 0.05 mm to 0.8 mm when the deflection reached -6.0 mm. The load then reduced gradually, reaching a residual strength of -53.9 kN at a deflection of -13.4 mm.

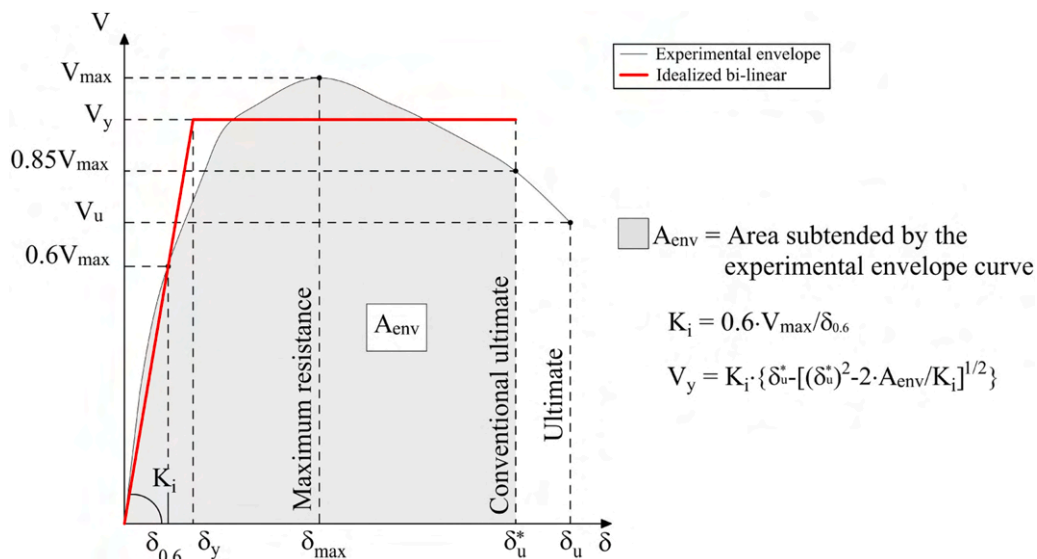
Fig. 10. Idealized load (V)-deflection (δ) bi-linear curve [37].

recommended by the Italian building code (NTC18) [37], which is described by the schematic of Fig. 10. The envelope curves were obtained by connecting the peak load points recorded during the first loading cycle at each level of imposed lateral displacement. For the specimen WO1, the whole monotonic curve without the unloading branches was considered. The curves resulting from bi-linearization are defined by five parameters, namely the initial stiffness K_i , which is conventionally assumed as $0.6 V_{\max}/\delta_{0.6}$, the deflection ($\delta_{0.6}$) at 60% of the maximum resistance (V_{\max}) on the pre-peak curve, the deflection at the elastic limit (δ_y), the yield resistance (V_y) and the ultimate deflection ($\delta_u^* \leq \delta_u$) corresponding to a conventional ultimate resistance not lower than $0.85 V_{\max}$. The value of V_y can be found by equating the areas subtended by the experimental bi-linear curve up to the deflection δ_u^* . Table 3 reports the parameters of the idealized curves plotted in Fig. 7.

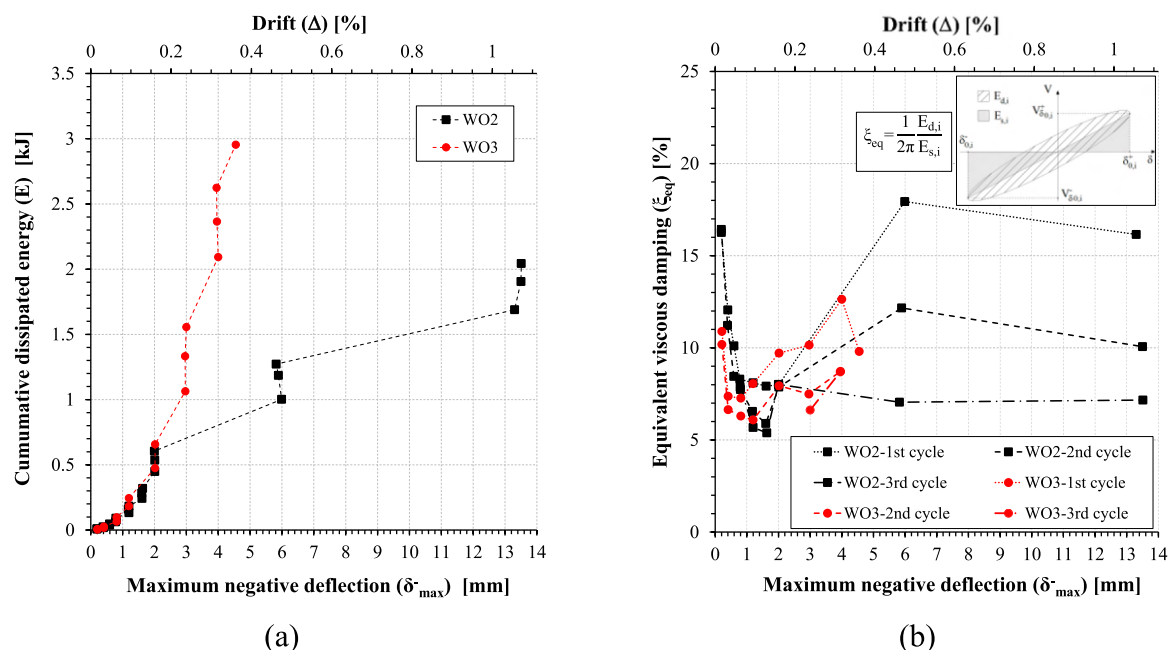
Fig. 11. Results exhibited by specimens WO2 and WO3: (a) cumulative dissipated energy (a) and (b) equivalent viscous damping ratio.

The dissipated energy (E) is presented in terms of cumulative energy dissipation, defined as the sum of energy dissipated over successive loading cycles. In Fig. 11a, the dissipated energy is plotted against the maximum negative deflection, which corresponds to the negative displacement (δ_{\max}^-) at the negative peak load (V_{\max}^-) attained within each loading cycle. Regarding the specimen WO2, the energy dissipation increased slowly until the up to a deflection of about 2 mm. For higher deflections the damage became more pronounced leading to a considerable increase in the area enclosed within each cycle, particularly in the negative loading direction. For deflections ranging from 2 mm to 13.5 mm, the cumulated energy increased from about 0.45 kJ to a maximum of 2 kJ, corresponding to an increase of 344 %.

The cumulative energy dissipated by wall WO3 is shown in Fig. 11a. The dissipated energy remained quite limited up to a negative lateral deflection of 1.2 mm. Between the 8th and the 9th loading cycle, corresponding respectively to a lateral deflection of about 1.2–2 mm, the dissipated energy increased with a significantly higher rate, resulting from the propagation of cracks mainly on the SFRM coating surface. During the last loading cycles the energy dissipation further increased so that the total cumulated energy attained a maximum value of 2.95 kJ, which corresponds to about 1.5 times that dissipated by the wall WO2.

As already noted in specimen WO2, the viscous damping ratio exhibited a gradual reduction as the number of cycles increased. This decrease started from an initial value of 10.8 % and reached a minimum of 6.1 % at a lateral deflection of 1.2 mm (Fig. 11b). For higher values of the deflection the damping ratio tended to increase up to a maximum of 12.6 %.

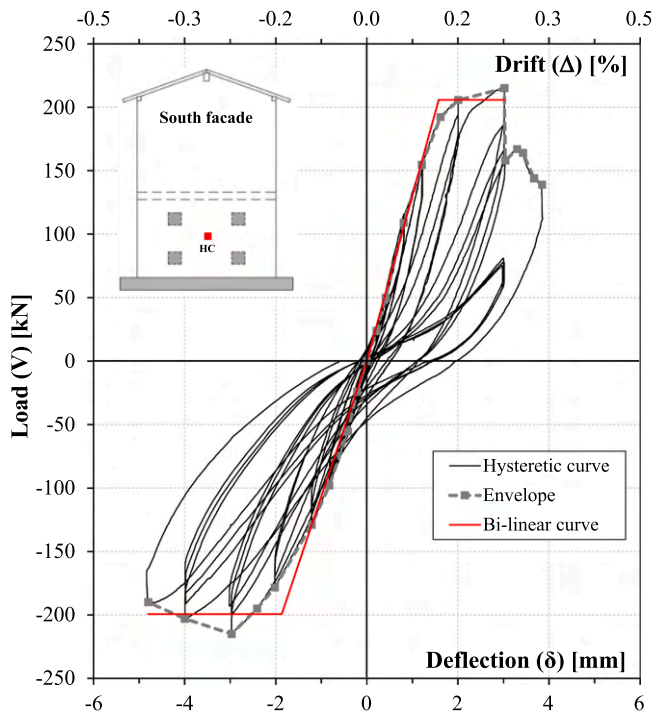
Fig. 12. Load-deflection response of the two-way spanning wall (WO3).

The hysteretic response and the envelope curve of wall WO3 are reported in Fig. 12. About the evolution of damage, Fig. 13 illustrates the crack pattern detected on both sides of the wall at net deflection levels of 2 mm and 4 mm, as detected by instrument HC3.

The response observed in the negative direction is very similar to that detected during positive loading. As illustrated in Fig. 12, the response remained linear up to a load of - 98 kN, corresponding to the activation of the first cracks visible on the inner surface of the wall. These cracks affected the vertical joints between the loading points, as well as the horizontal joints located in the middle of the wall. As deflection increased to - 2.0 mm, cracks further propagated across the uncoated masonry surface (see the light-blue cracks in Fig. 13a), while the green pre-existing horizontal cracks at the top and bottom of the outer face reopened, leading to further stiffness degradation. The peak load in this direction was - 215 kN at a deflection of - 3.0 mm. In the post-peak phase, sub-vertical cracks developed on the inner face, extending

The bi-linearization of the hysteretic curve (Fig. 12) provides
