Rolling contact fatigue perspective of damage mechanism in 3D printed 17–4 PH stainless steel

ABSTRACT

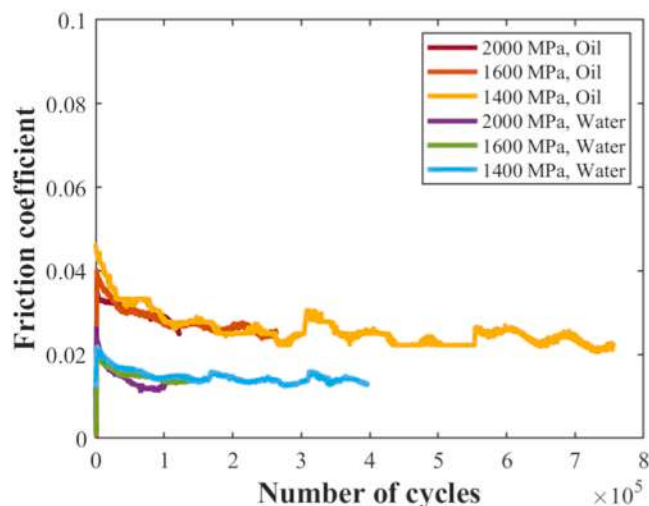
Fig. 7. Trend of the friction coefficients in the tests.

The friction coefficient trends are illustrated in Fig. 7. Regardless of the contaminant used, the friction behaviour follows a characteristic transient phase: after an initial peak, the coefficient gradually decreases until stabilizing. For tests conducted with oil, the steady-state friction coefficient stabilizes around 0.027, whereas for tests performed with

water, it reaches a lower equilibrium value of approximately 0.013. This difference suggests that water lubrication leads to a significantly lower friction regime, potentially influencing the fatigue behaviour of the tested materials. The periodic variations observed in the friction coefficient under the 1400 MPa load with oil lubrication, as shown in Fig. 7, can likely be attributed to the combined effects of surface evolution and third-body interactions. At this intermediate load level, micro-pitting or mild surface wear may intermittently modify the contact topography, influencing the friction response over time. Additionally, the formation and detachment of wear debris or oxide particles can act as a third body within the contact, momentarily altering the local friction conditions before being expelled or integrated into the surface. These phenomena

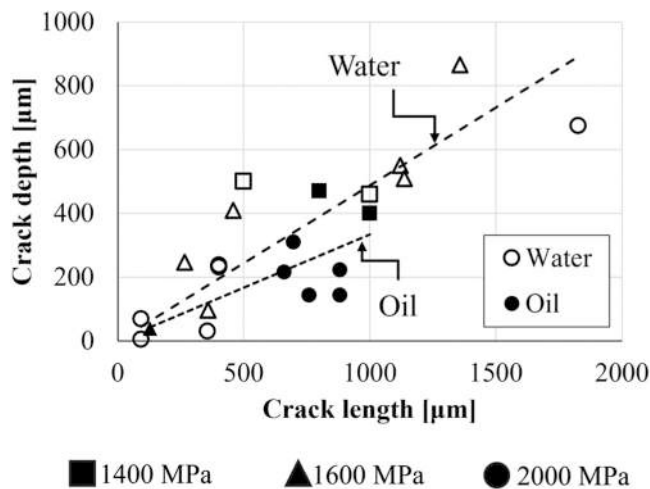
Fig. 16. Statistical distribution of cracks according to lubricant and contact pressure.
