# Examining Wear Mechanisms in Railway Wheel Steels: Experimental Insights and Predictive Mapping

**Keywords:** wear mapping; rolling contact; fatigue index; railway wheel

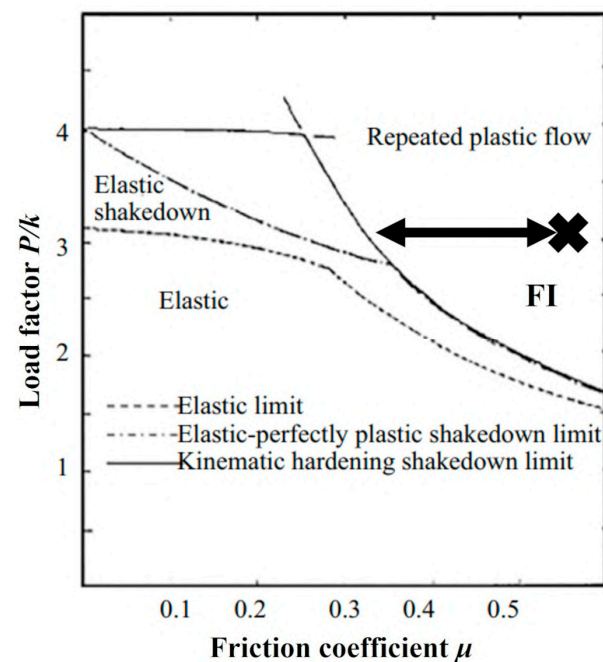
$$FI = \mu - \frac{k}{P} \quad (2)$$

where  $\mu$  is the friction coefficient,  $k$  is the cyclic shear yield strength, and  $P$  is the applied contact pressure.

**Figure 2.** Example of a shakedown map for cylindrical contact.

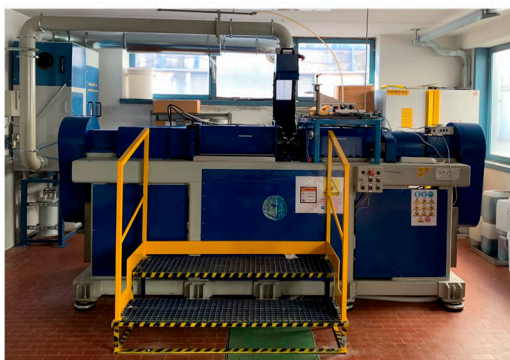
This research showcased findings derived from experimental tests conducted utilising the advanced bi-disc apparatus situated at the University of Brescia. Figure 3 illustrates the setup of the apparatus. The system was outfitted with two mandrels, one of which was positioned on linear air slides, operated independently by two alternating current (AC) 33 kW motors capable of reaching speeds of 1200 rpm. A servo-hydraulic actuator was utilised to generate the contact load and manage the approach motion, with a capacity of 75 kN. Speed, torque, and normal load were recorded at a sampling frequency of 5 Hz using a dedicated National Instruments data acquisition system.

**Figure 3.** Twin-disc testing machine.

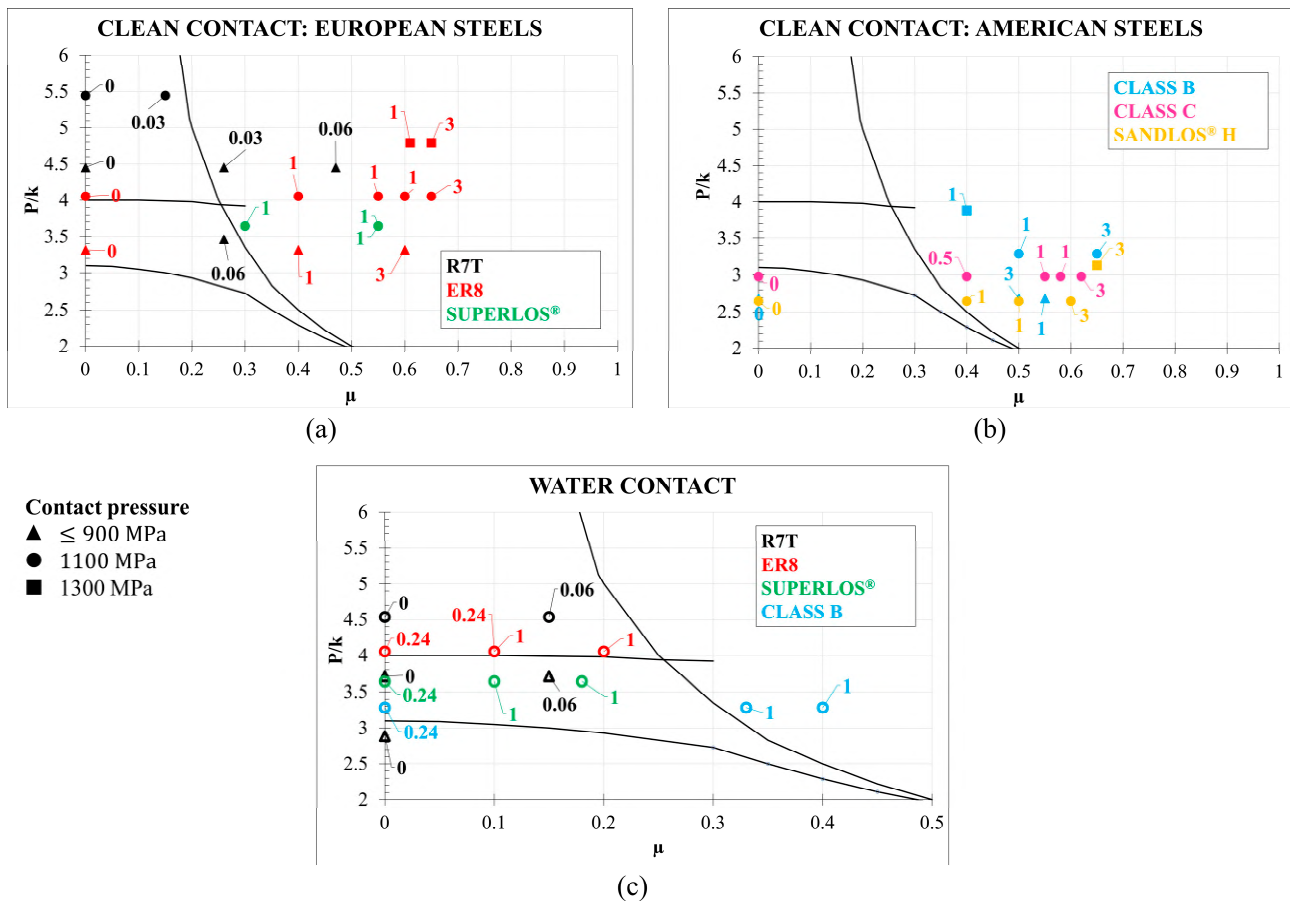
Figure 4 portrays the shakedown maps for cylindrical contact and the experimental conditions (coefficient of friction and load factor  $\frac{k}{p}$ ) in clean contact (Figure 4a,b) for European and American steels, respectively, and in lubricated contact (Figure 4c). The numerical values represented correspond to the percentages of the slip ratio. Fixing the

contact pressure and increasing the slip ratio generally causes the friction coefficient to rise, moving the operation point to a ratcheting area both in clean and lubricated contact. In clean contact, the American steels generally exhibit lower load factors than the European steels when tested under the same contact pressure. This is ascribed to the higher shear yield strength of American steels, translating into an increased likelihood of less-resistant steels being subjected to ratcheting (since the ratcheting area widens with the strength reduction). As the shakedown is increasingly overcome, more plastic deformation accumulates until failure occurs.

**Figure 4.** Shakedown map for cylindrical contact showing the operating conditions: (a) European wheels in clean condition, (b) American wheels in clean condition, and (c) European and American wheels in water condition.

Additional information given by the shakedown maps is the position of the maximum shear stress. When the coefficient of friction increases beyond a threshold of about 0.3, the maximum stress arises at the surface contact. In clean contact (R7T excluded), we conclude that, with a slip ratio higher than 1%, the surface layers of the samples undergo maximum stress and ratcheting. In contrast, for the water condition, the coefficient of friction was generally lower than 0.3; therefore, the maximum stress is in the sub-surface. In these circumstances, steel cleaned from defects, including those not visible to the naked eye, is essential. However, the lubricated tests were run with constant application of water. A different response would result if the same tests were conducted with the previous clean contact cycles to initiate cracking [102,103].

However, in CLASS B, this mechanism was less pronounced; indeed, its wear behaviour was less affected by the load, as shown in Figure 4. On the other hand, when the slip ratio increased to 3%, the flake dimensions did not vary regardless of the type of steel, but the surface was smoother, as also witnessed by Bolton et al. [43].

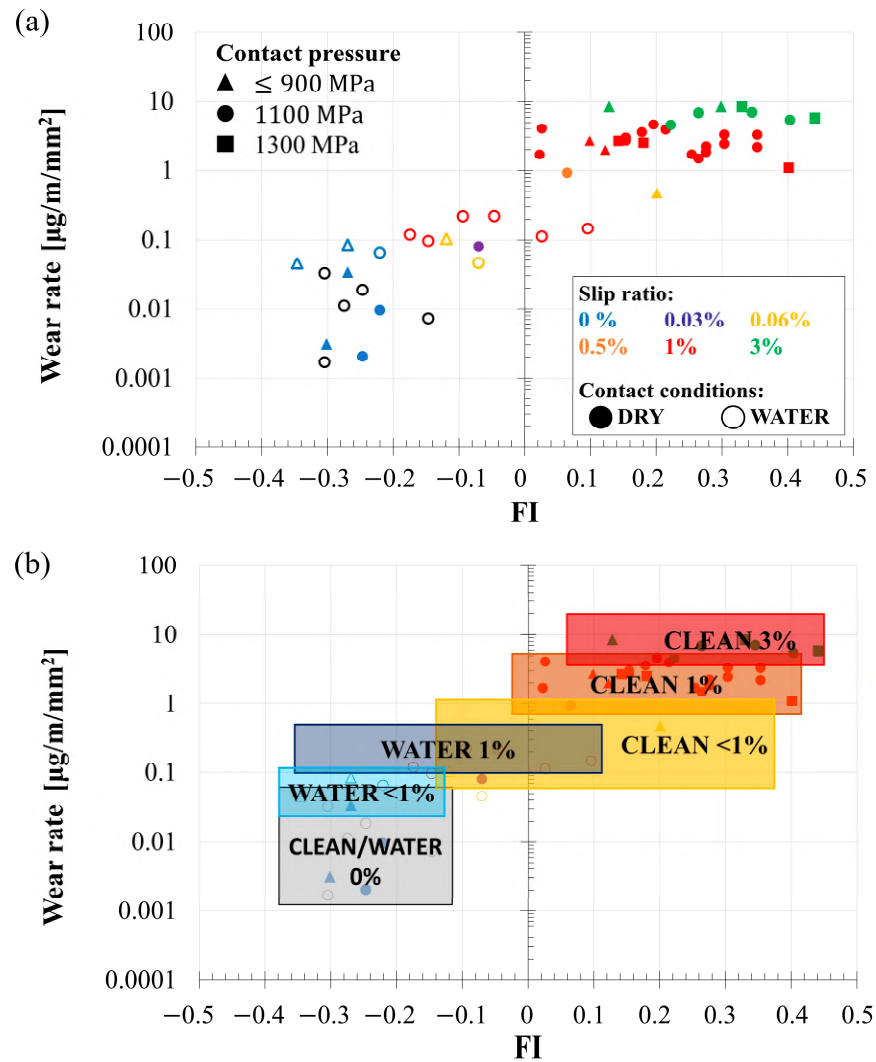
Figure 5 shows a map defined to predict the wear rate once the  $FI$  is known. Wherever the values of the wear rate were not available in the cited works, they were calculated according to Equation (1). We can distinguish clean contact from lubricated contact if we exclude the pure rolling condition. First, we notice that  $FI$  values in wet contact are

generally lower than in clean conditions, except for the pure rolling tests, which show similar  $FI$ s regardless of the lubrication. The lower  $FI$  in the lubricated tests can be ascribed to the lower friction coefficient. The wear rate increases with the slip ratio. In detail, in clean conditions, the wear rate increased by about four orders of magnitude, passing from the pure rolling to a slip ratio equal to 3%, while in the lubricated test, the wear rate increased by two orders of magnitude from a slip ratio of 0% to 1% [103].

**Figure 5.** Wear rate evolution according to  $FI$  (a) for clean and lubricated tests showing the slip ratio and (b) a cluster map of the operating conditions.

The scattering in the  $FI$  values at a constant slip ratio does not seem to depend on the contact pressure, but it can be attributed to loose machine tolerances for the discs and differences in specimen roughness values and material properties.

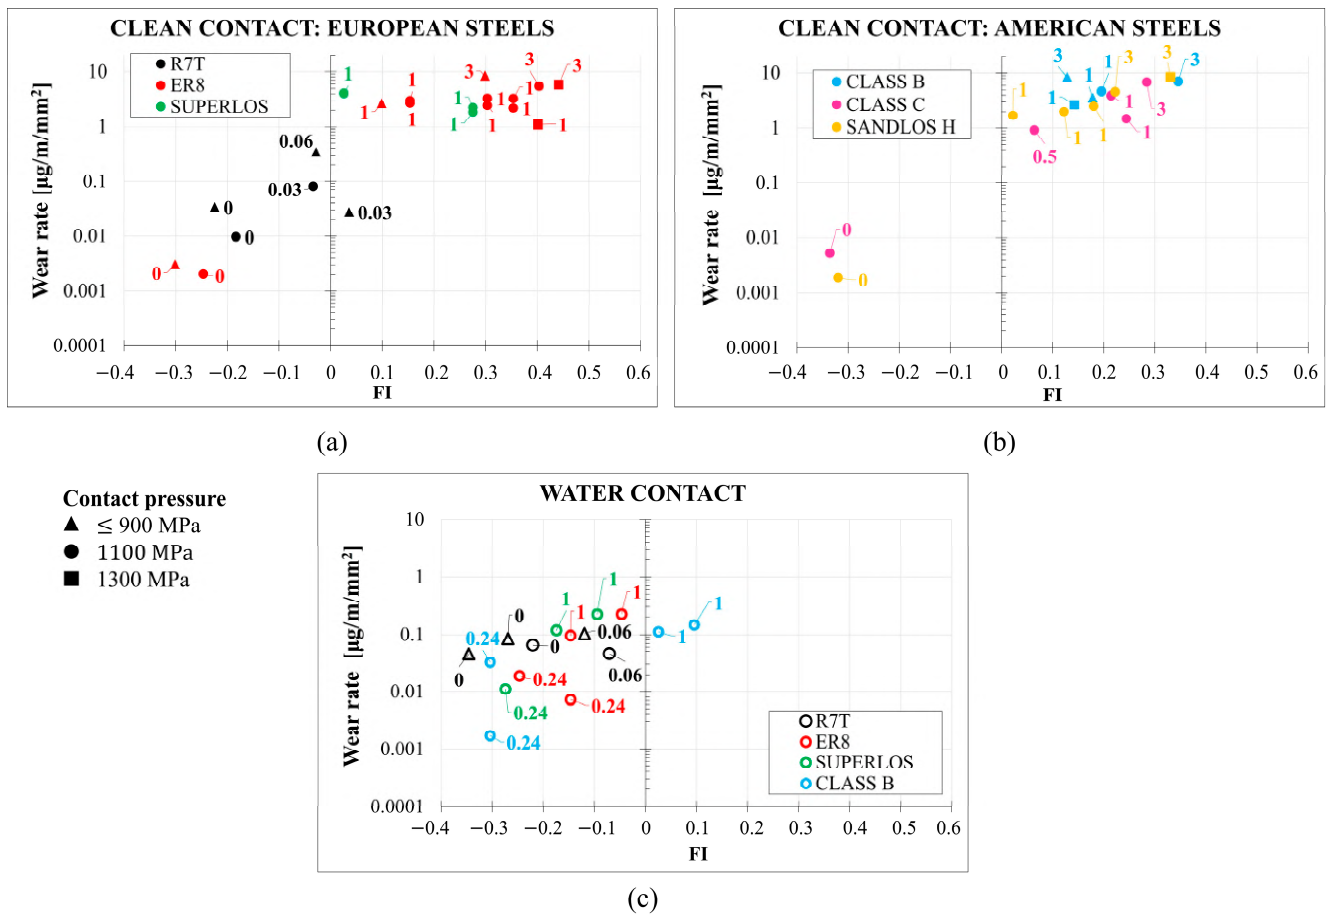
Figure 6 shows similar results, focusing on the type of wheel steel. The wear trend in clean contact exhibits no clear differences. All the rail–wheel specimens were produced in the 2010s, apart from R7T, which dates to the previous decade. This difference is noticeable since the R7T steel tested at 900 MPa and a slip ratio of 0.06% yielded a  $FI$  comparable to that of the ER8 specimens tested at 1300 MPa and a slip ratio  $\geq 1\%$ . Moreover, had R7T been tested at 1300 MPa and slip ratios higher than 1%, its wear rate might have been higher than ER8. Figure 5 also shows that wear rates gradually decreased as new and improved materials were introduced. Indeed, the equivalent R7T produced by the same

company in the following years had higher mechanical properties, which would have led to lower *FIs*.

**Figure 6.** Wear rate evolution according to *FI* for (a,b) clean and (c) lubricated tests, according to the wheel material.

If we compare American and European steels tested in clean conditions, excluding a few cases, the American steels show lower *FIs* and slightly lower wear rates, likely because their hardness values are comparable to those of rail materials.

The *FIs* were generally less than zero in the lubricated tests, even with a 1% slip ratio and 1100 MPa of contact pressure. The only exception was CLASS B. Once again, R7T tested at lower contact pressures and slip ratios overlapped with the more recent steels tested at more critical conditions.

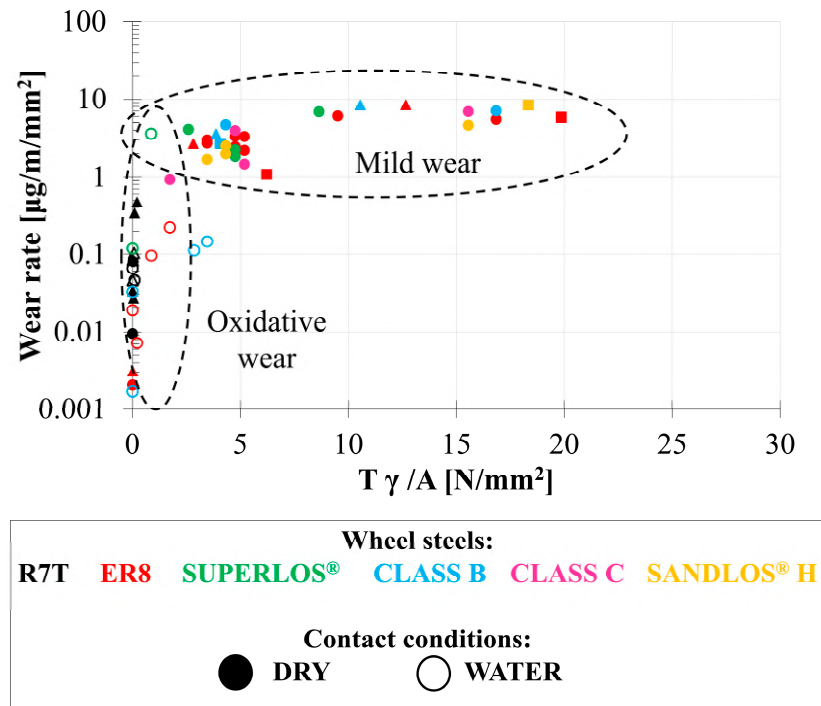
The wear rate was also examined based on the  $T\gamma/A$  parameter (Figure 7). We found that the tested samples experienced either oxidative or mild wear, typically identified as a Mode I regime [70,72]. Samples tested in clean conditions and with pure rolling or slip ratios lower than 1% suffered from oxidative wear regardless of the contact pressure. Increasing the slip ratio led to the transition from oxidative to mild wear. When oxidative wear occurred, the wear rate was lower than  $1 \mu\text{g}/\text{m}/\text{mm}^2$ , while it varied between 1 and  $10 \mu\text{g}/\text{m}/\text{mm}^2$  in the case of the mild regime.

Figure 7. Wear regimes identified during bi-disc testing.
