## POSTER 4 - How Can We Renew and Make Villages More Attractive Thanks to a New Aesthetical Image? The Case Of Monteciana, in The Municipality of Nave (Brescia, Italy)

Barbara Badiani, Barbara Scala, Federico Giustacchini

## UNISCAPE En-Route International Seminar RESILIENT LANDSCAPES FOR CITIES OF THE FUTURE

### How can we renew and make villages more attractive thanks to a new aesthetical image? The case of Monteciana, in the Municipality of Nave (Brescia, Italy)

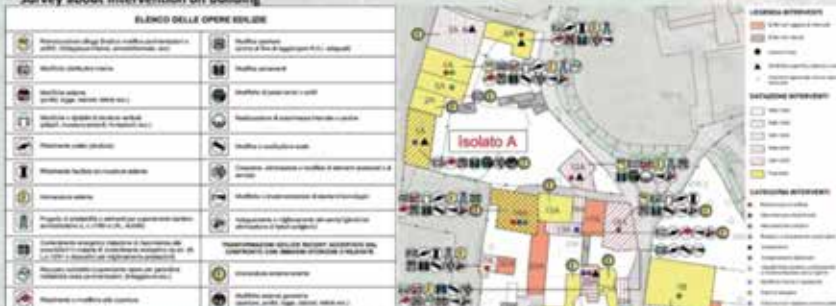
#### Survey about intervention on building

The number of intervention have increased from 1980 up to now and some buildings have had more than one intervention (especially for ordinary maintenance and this means that a special attention has been paid to the aesthetic of the buildings). The most common intervention has concerned the internal rooms distribution. While the most common intervention on the structure have aimed to make roofs safe and, in a few cases, to make the attic suitable to live in. The intervention that change the volume, altering the form and the typology of the building, were carried out after 1990.

The traditional analysis based on both the historical cadastral maps, useful in recognizing the period of each part of the buildings, and on site surveys, useful in classifying the building typology and integrity, have been completed by an analysis of building permits from 1980 up to now. Thanks to the information collected, for each building the following elements have been pointed out:

- if and when the building was the object of an intervention;
- the type of intervention (ordinary and extraordinary maintenance, restoration, completion, change of destination, etc.)
- which parts, structural or not, of the building have been modified.

The number of intervention have increased from 1980 up to now and some buildings have had more than one intervention (especially for ordinary maintenance and this means that a special attention has been paid to the aesthetic of the buildings). The most common intervention has concerned the internal rooms distribution, with the consequent changes in the form and position of the windows (to respect the window/floor surface ratio). While the most common intervention on the structure have aimed to make roofs safe and, in a few cases, to make the attic suitable to live in (according to the local Urban Plan that doesn't discourage this type of intervention). The intervention that change the volume, altering the form and the typology of the building, were carried out after 1990 (enlargement of the buildings to make new cover spaces or an increase in the height of the roof).
